# Effect of Soil Structure and Field Drainage on Water Quality and Flood Risk

Hallett, P., Hall, R., Lilly, A., Baggaley, B., Crooks, B., Ball, B., Raffan, A., Braun, H., Russell, T., Aikenhead, A., Riach, D., Rowan, J., Long, A. (2016). Effect of soil structure and field drainage on water quality and flood risk. CRW2014\_03

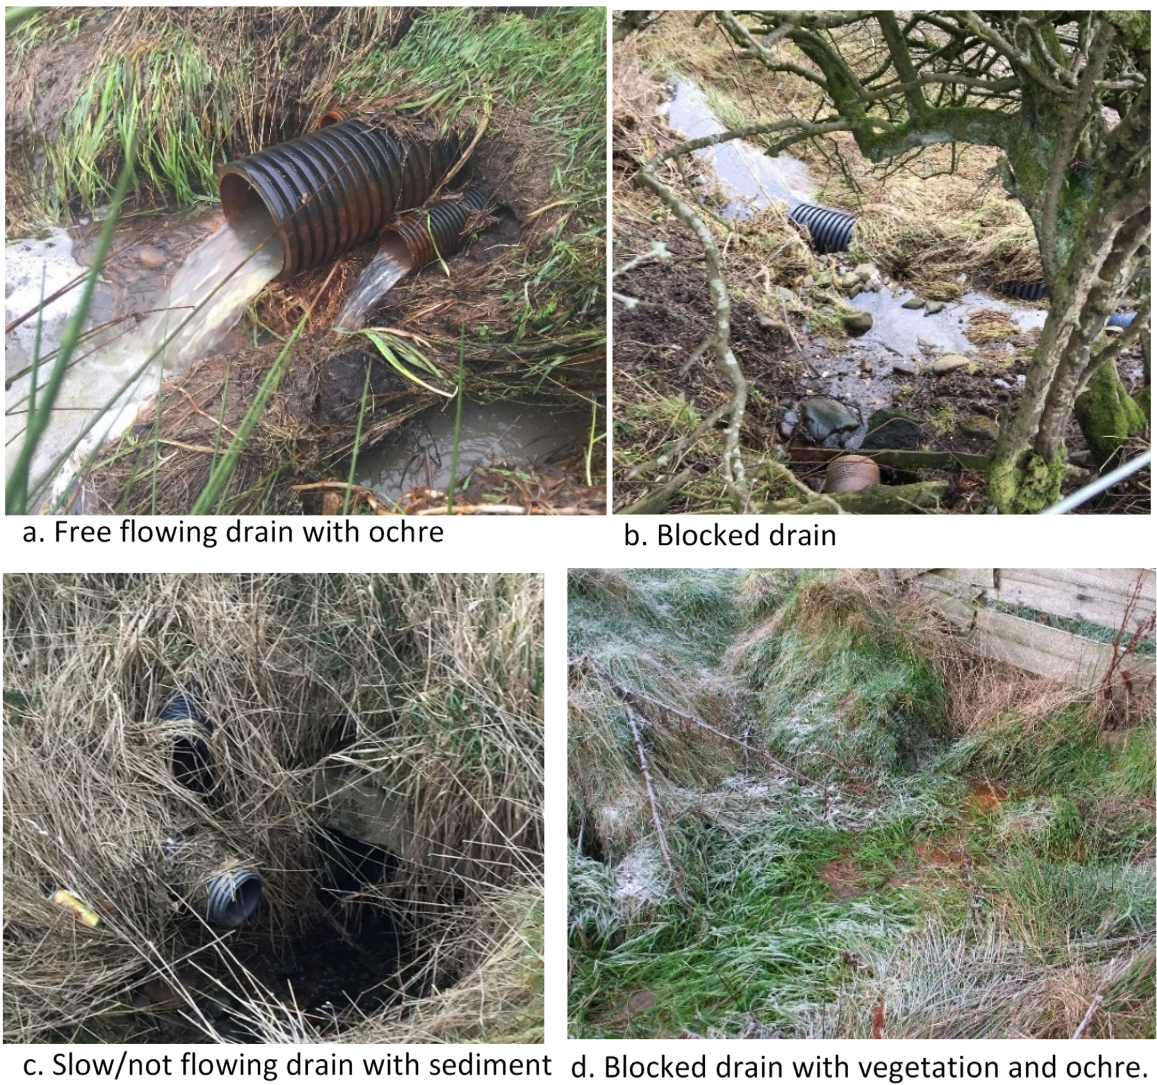
Figure 15 – Visual assessment of agricultural drains in ditches.

We also assessed the current state of agricultural drainage in the 120 fields surveyed. This examined sediment build-up and blocking of drains where they were visible in drainage ditches (Appendix 6). The photographs in Figure 15 illustrate differences found in the visual assessments of drainage outfalls, with the results summarised in Table 2. We also provided a questionnaire to farmers on their field drainage systems (Appendix 7), which we aimed to complete during the field visit. A total of 28 drainage questionnaires were completed by farmers and surveyors, results are shown in Table 3. A farm report template is given in Appendix 8.

Visual assessments of drainage outlets of each field showed a broad range of conditions and mainly free flowing drains. As drainage was mainly assessed in wet weather conditions the likelihood of finding outlets was increased, however as shown in Figure 15 blocked drains were difficult to identify. While 59% of the fields visually assessed showed functioning drainage outlets, there is a limitation to the study as drains may have been missed.

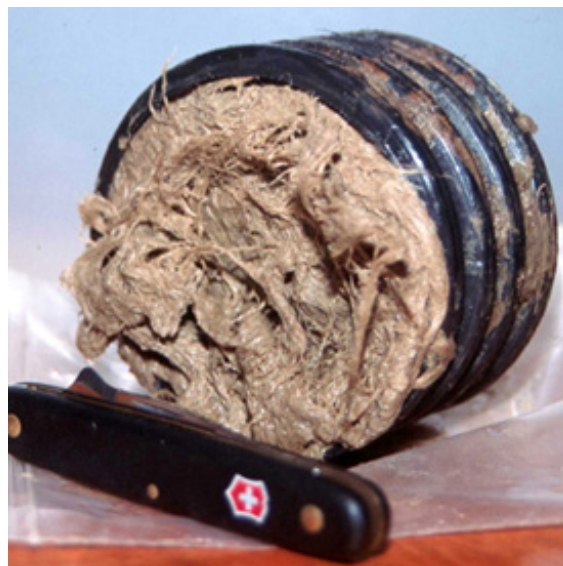
**Figure A1:1** – Agricultural drains can be blocked by a mix of roots and soil. Source: Leuty (2012).

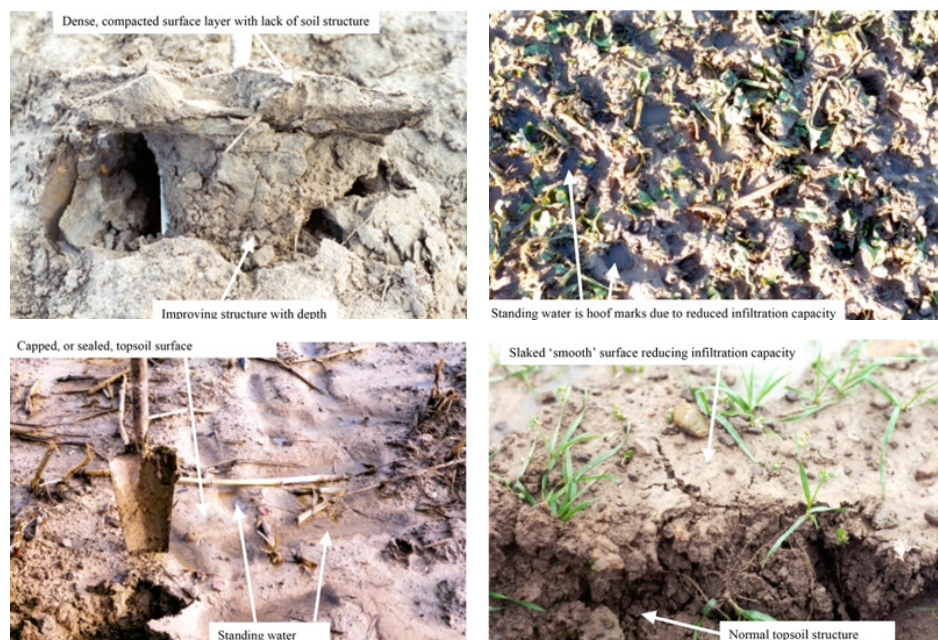
**Figure A1:2** - Holman et al. (2002) observed (from top left clockwise) compacted topsoil, hoof damage with standing water, surface slaking and surface capping indicating soil structural degradation in four UK catchments.

For late harvested crops, however, the incidence was 55%. Photographs from their report illustrating soil structural degradation are shown in Figure A1:2. By combining their new data with the National Soil Map of England and Wales, a simple model (HOST) predicted increases in runoff water reaching rivers of 0.5 to 12%. Although this represents a significant increase, which suggests greater flood risk, Holman et al. (2002) were cautious about inferring too much from this desk-based study.
