Dynamic Coast - National Coastal Change Assessment: Cell 10 - Orkney

Dynamic Coast – Scotland's National Coastal Change Assessment

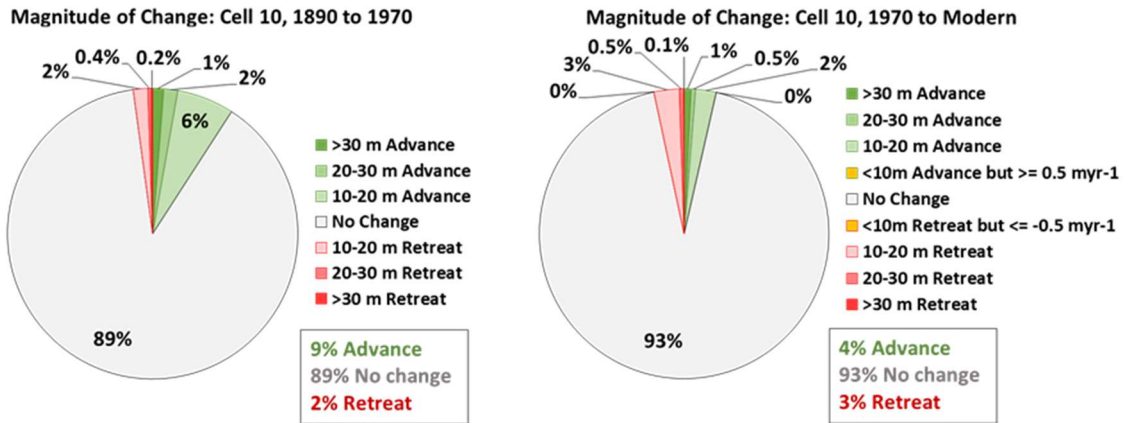
Figure 10.2: Coastal change results for Cell 10 showing the proportional amount of change in the historical (ca. 1890-1970 normalised) and recent (ca. 1970-Present) periods. Rounding errors may produce small % differences between Figure 2 and Figure 10.2.

The period from the 1970s to modern spans 37 years, so the historical period data has been normalised to 37 years to allow comparison with the modern period. When this adjustment has been applied the extent of erosion has increased from 3% to 4%, whilst accretion has reduced from 9% to 4% and stability has increased from 89% to 93% (

Figure 10.2). Rates of change have also increased, with erosion rising from 0.2 m/yr to 0.4 m/yr and accretion from 0.3m/yr to 0.75 m/yr. Taken together the modest changes in extent, with quickening in rates of change, is comparable with other more rock-dominated cells, where the level of protection offered by adjacent rocky shores is higher, than on more exposed cells. So whilst compared with more open cells the situation in cell 10 (Orkney) is not as bad, the increase in erosion rate is a concern.

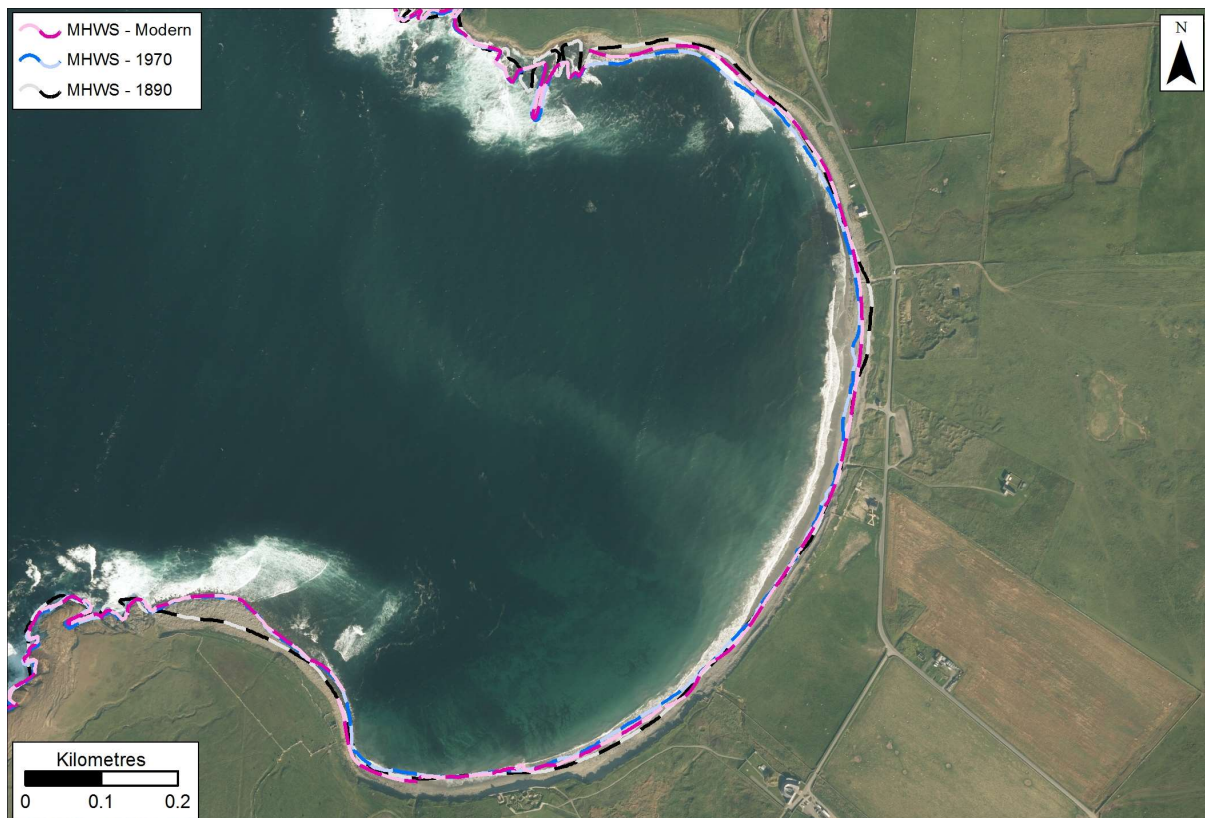
Figure 10.3: MHWs position in 1890, 1970s, and Modern datasets at Bay of Skail. Getmapping are our current providers of Scotland-wide digital aerial imagery © Getmapping plc.

Between 1900 and 1972 the position of MHWs has remained largely stable with some isolated areas of accretion over the 72 years (Figure 10.3). At first glance this contrasts with the evidence of long-lived storm driven coastal erosion. However, this is inconsistent in that short-term changes can mask longer term trends. In addition, it is also possible for the upper beach to respond differently to waves than lower sections of the beach so that the upper beach (above MHWs) may experience

Whilst the 1972 MHWS is largely coincident within the vicinity of the sea wall at Skara Brae, accretion has occurred between the end of the defences and the Mill at Voydale to the east, with the tide line moving some 14 m seaward (0.2 m/yr) (Figure 10.4). The Mill House appears at the edge of the beach in 1972, with all four walls intact. Since all that now remains is the landward wall before the seaward edge of the dune is encountered, this indicates upper beach and dune retreat despite apparent MHWS stability. Additionally, the changing position of the dune vegetation edge within air photography commissioned by Historic Scotland in 2003, showed 0.3-0.4 m/yr erosion. Further north east of the Mill the 1972 and 1900 tidelines are largely coincident for the next 400 m, northward of which MHWS has advanced seawards between 1900 and 1972 by up to 20 m (0.3 m/yr). Within the remainder of the bay (to the north) MHWS has advanced seawards between 1900 and 1972, by up to 20m (0.3 m/yr) (Figure 10.3).

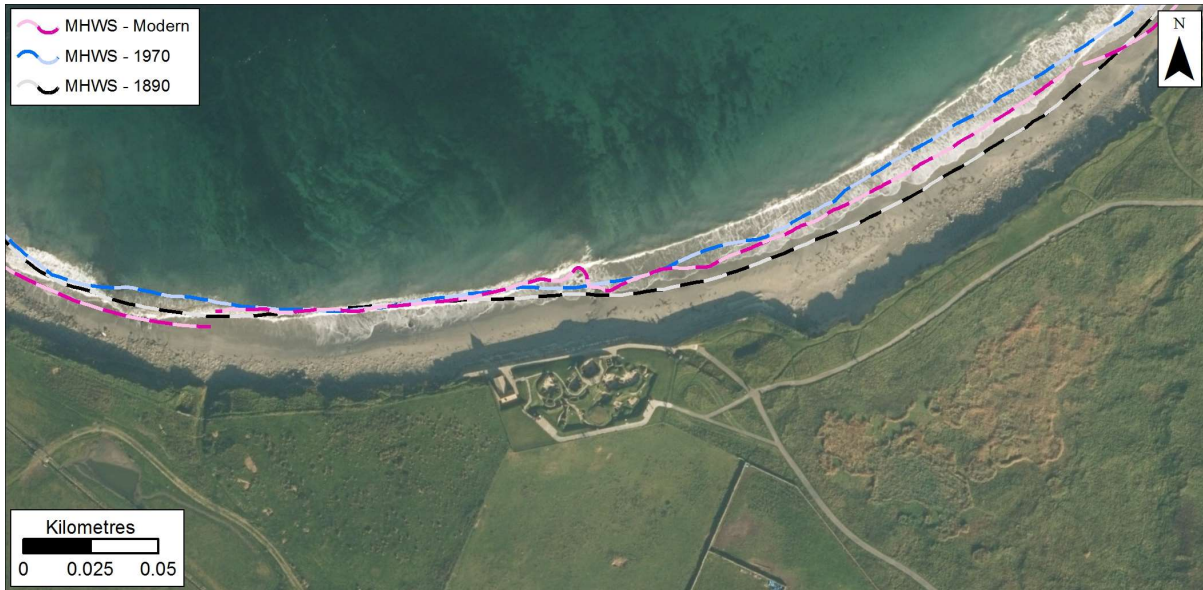
Figure 10.4: MHWS position in 1890, 1970s, and Modern datasets at Skara Brae. Getmapping are our current providers of Scotland-wide digital aerial imagery © Getmapping plc.

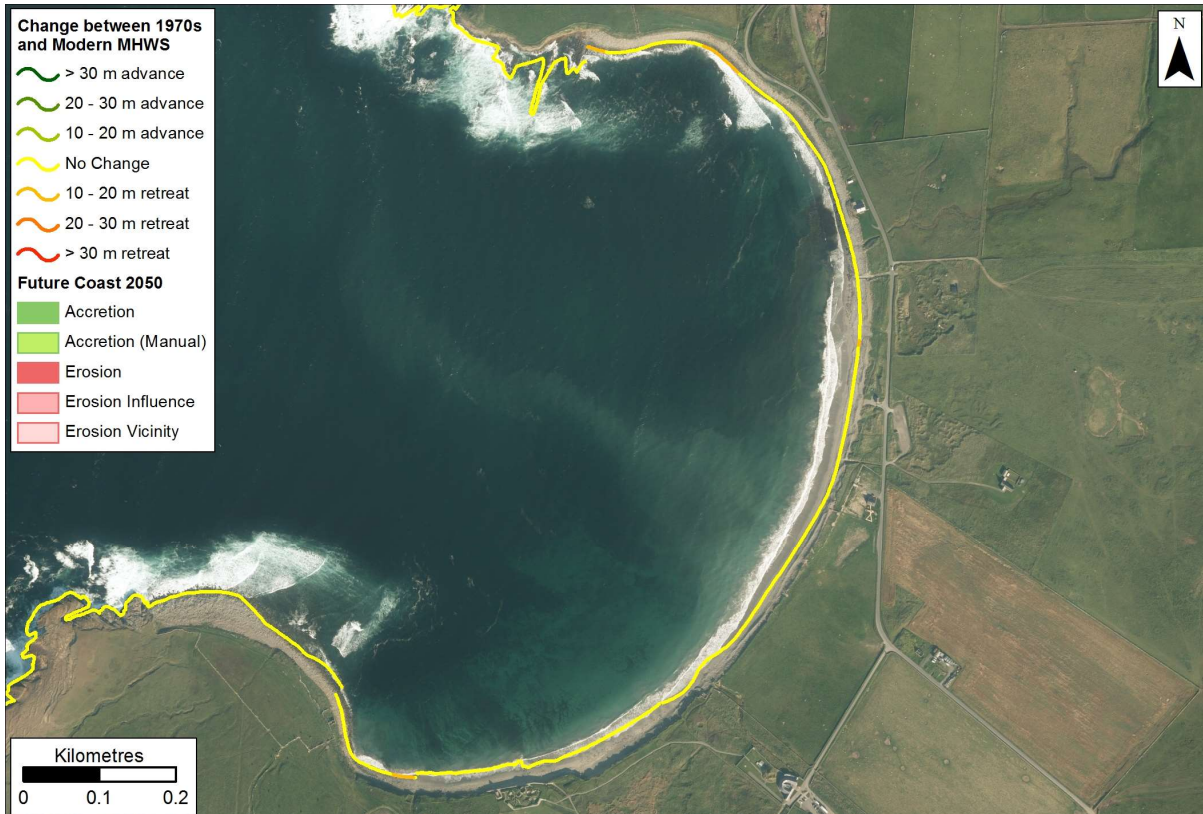
Figure 10.6: Possible future coastline position in 2050 based on rates between 1970 and Modern MHWS data at Bay of Skail. Getmapping are our current providers of Scotland-wide digital aerial imagery© Getmapping plc.

Future Vulnerability: Whilst the Neolithic village at Skara Brae lies behind a sea wall, the remainder of the bay is largely undefended apart from unofficial tyre and netting defences fronting a house further north (Sea View). The Mill House at Voydale has been largely lost since 1972. The changes at the Bay of Skailly may highlight a possible disconnect between MHWS and the beach crest / vegetation edge, as such further analysis is required before a detailed vulnerability assessment can be carried out. Rates of recent MHWS retreat shown by the TLS in the rest of the bay are modest (15m in 44 years = 0.3 m/yr) (Figure 10.6), however it is not clear if this sample of the bay is representative of a wider pattern.

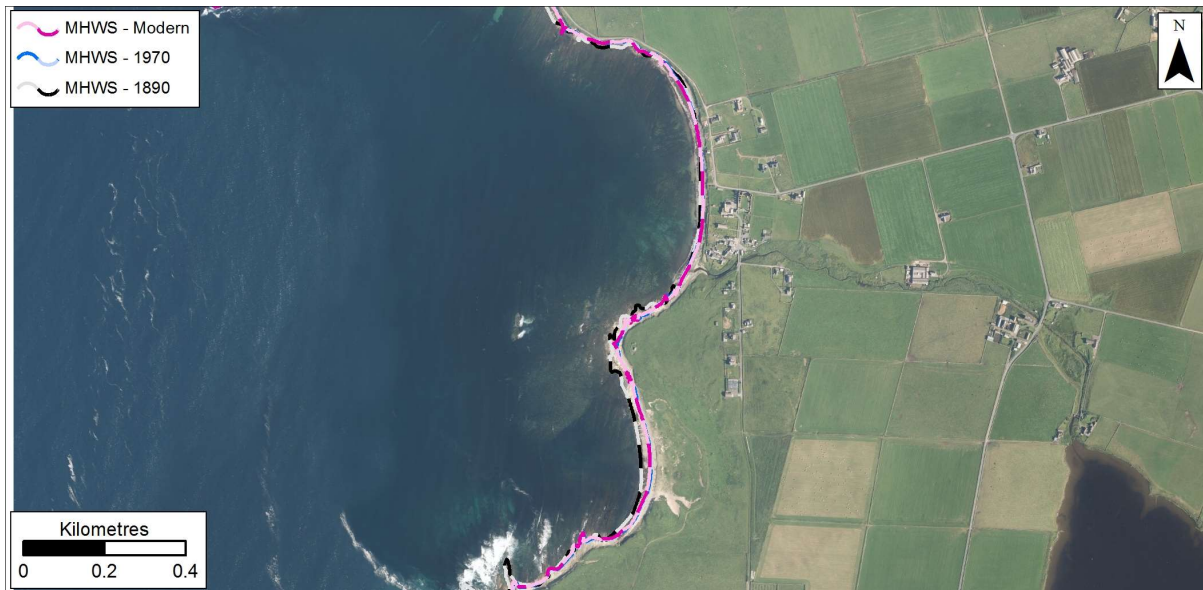
Figure 10.7: MHWS position in 1890, 1970s, and Modern datasets at Birsay Bay. Getmapping are our current providers of Scotland-wide digital aerial imagery© Getmapping plc.

At Brough Head modest changes occur to the alignment of the gravel beach at the end of the tidal causeway. More significant changes occur at the eastern end of the causeway on both Mainland Shores of the Point of Buckquoy. On the north shore, the 1974 MHWS line lies some 30 to 40 m inland of the 1900 equivalent and suggests that the soft erodible glacial tills that lie on top of the bedrock shore platform have been removed over this period. Indeed, the current position of the cliff line and vegetation limit lies up to 20 m landward of the 1971 MHWS position along much of this stretch of exposed coast.

Further south within Birsay Bay there has been very modest and statistically insignificant erosion within the vicinity of the Earl's Palace (up to 7m between 1903 and 1971, 0.1m/yr). However, given the density of cultural heritage within the bay this may present a significant risk. Some 60 m of defences were installed in front of the historically important graveyard that reclaimed 2-3 m of land from the beach, although the 1903 map shows the buildings were then just as perilously close to the beach as they are currently.

Further south from the Earl's Palace, towards Point of Snusan and Mount Misery, erosion increases with up to 20 m losses occurring between 1900 and 1974 (0.3m/yr). This is compounded by a further 10 m of loss beyond the 1971 line to where the vegetation and cliff line is depicted in the modern air photography. Like many of the exposed beaches here, extensive storm deposits lie above MHWS.

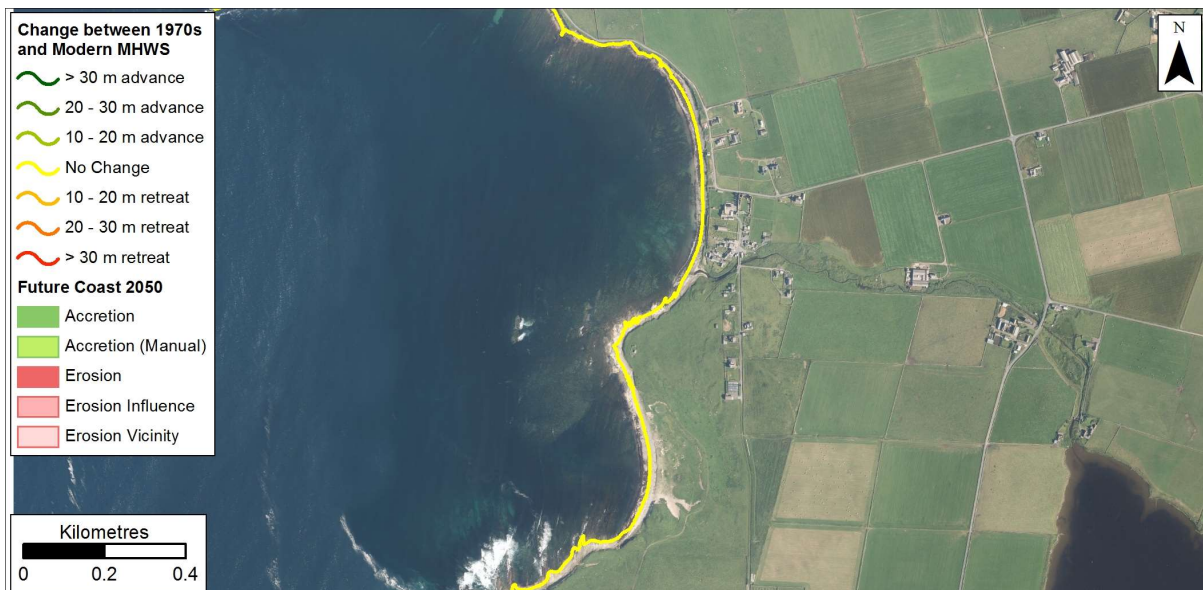
Figure 10.8: Possible future coastline position in 2050 based on rates between 1970 and Modern MHWS data at Birsay Bay. Getmapping are our current providers of Scotland-wide digital aerial imagery© Getmapping plc.

Future Vulnerability: As the the latest MHWS line is the same as the 1971 MHWS position, ‘no change’ is seen to have occurred at this location (Figure 10.8). Possible future change is therefore not estimated here. Apart from the farm buildings and church at Birsay, much of the land lies in agricultural use. However, from an archaeological perspective vulnerability might be gauged to be higher since there are known archaeological and cultural heritage interests within this area and there is potential for unknown sites that remain to be found.

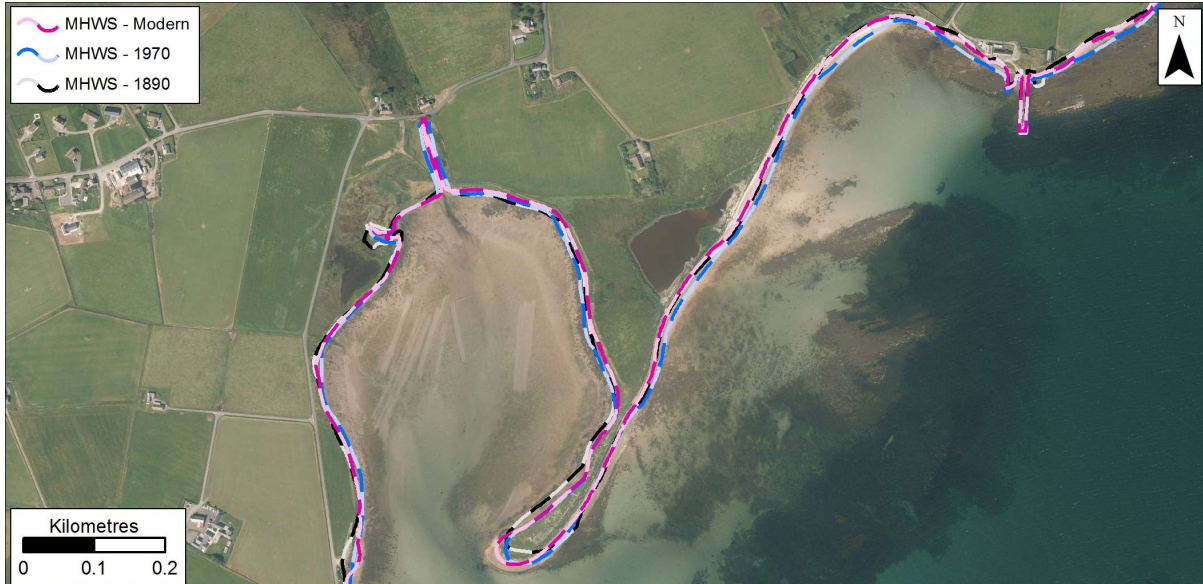
Figure 10.9: MHWs position in 1890, 1970s, and Modern datasets at Tankerness. Getmapping are our current providers of Scotland-wide digital aerial imagery© Getmapping plc.

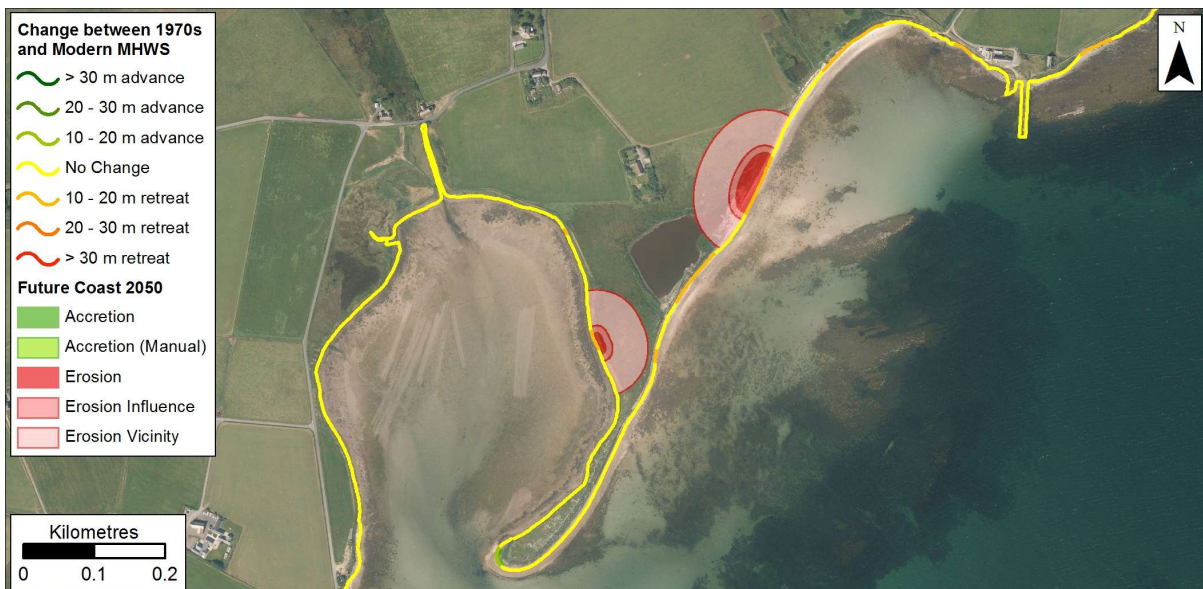
Figure 10.10: Possible future coastline position in 2050 based on rates between 1970 and Modern MHWs data at Tankerness. Getmapping are our current providers of Scotland-wide digital aerial imagery© Getmapping plc.

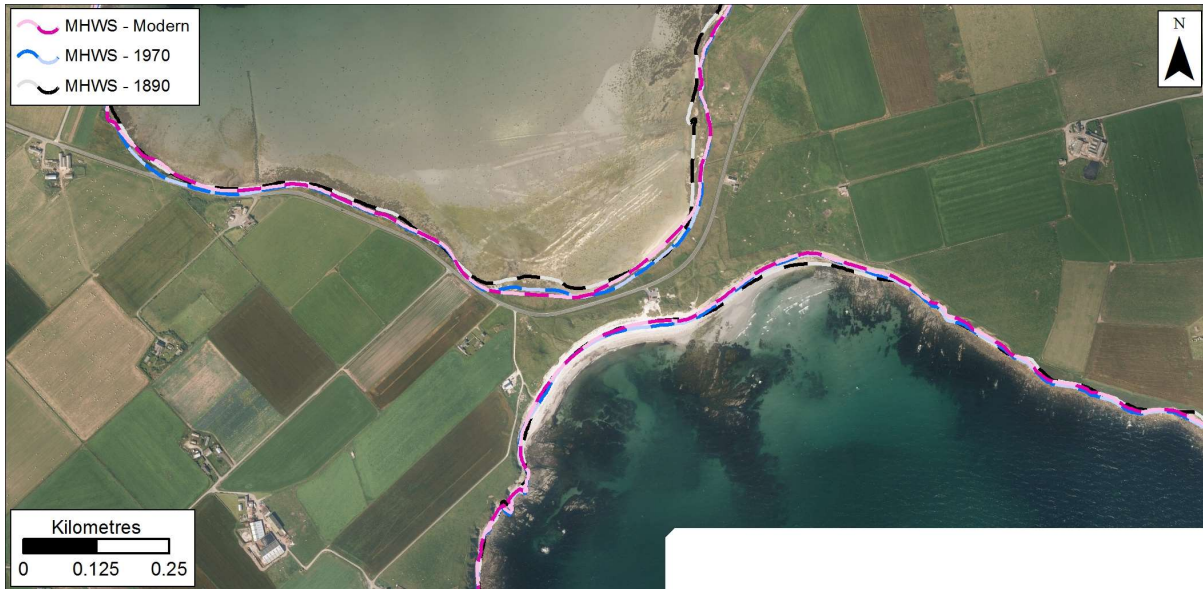
Figure 10.11: MHWS position in 1890, 1970s, and Modern datasets at Dingieshowe Bay. Getmapping are our current providers of Scotland-wide digital aerial imagery© Getmapping plc.

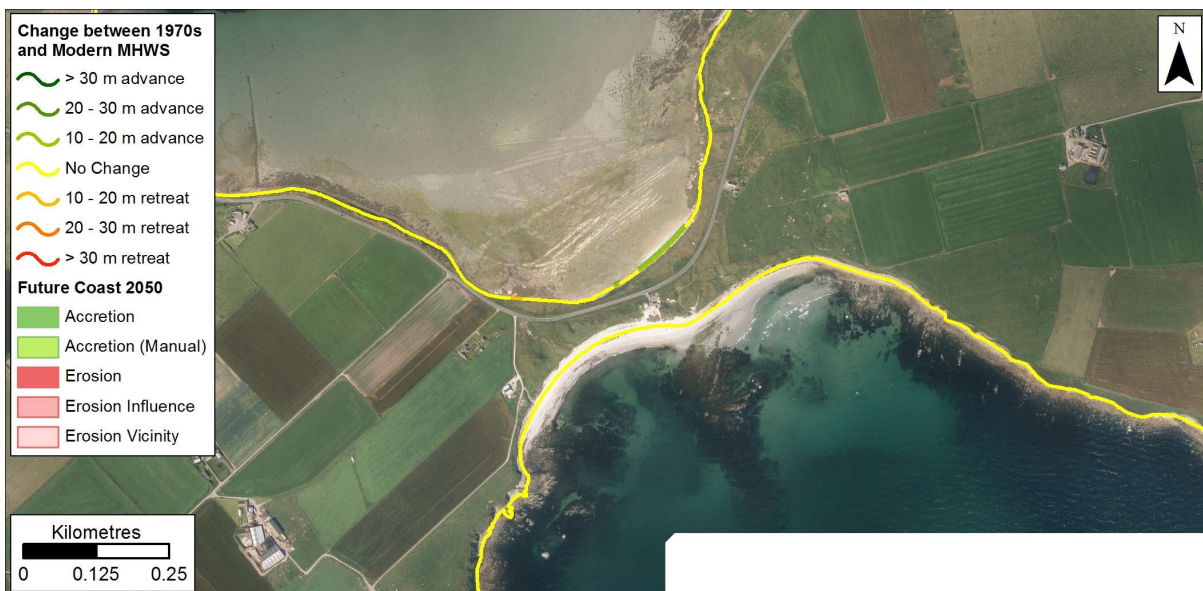
Figure 10.12: Possible future coastline position in 2050 based on rates between 1970 and Modern MHWS data at Dingieshowe Bay. Getmapping are our current providers of Scotland-wide digital aerial imagery© Getmapping plc.

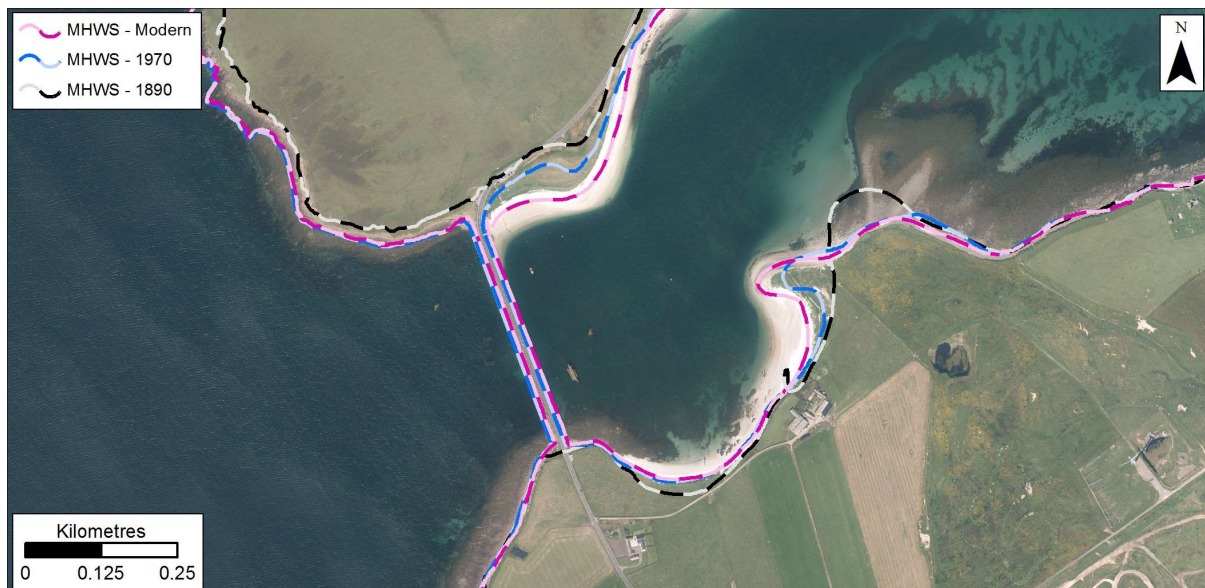
Figure 10.13: MHWS position in 1890, 1970s, and Modern datasets at Churchill Barrier No. 3. Getmapping are our current providers of Scotland-wide digital aerial imagery© Getmapping plc.

Historic Change: The Churchill Barriers were formed in the Second World War from cement blocks to connect Mainland Orkney to the islands of Lamb Holm, Glimps Holm, Burray and South Ronaldsay and so close off the pre-existing narrows. Small changes can be found on the shores adjacent to the first three northern barriers. Here, the blocking of the narrows has resulted in the advance of MHWS by up to 80 m metres (1m/yr) or the retreat of MHWS of up to 60m metres (0.7m/yr) as shown at Churchill Barrier No. 3 at Weddell Sound (Figure 10.13). However, the most impressive changes have occurred along the eastern flank of the fourth barrier that connects South Ronaldsay with Burray (Figure 10.14). The construction of the barrier interrupted the westward sediment supply from the North Sea into Scapa Flow. Between 1903 and 1983 up to 120 m accreted on the southern shore at Ayres of Cara (1.5 m/yr) and 70m on the northern shore (0.8 m/yr) However, the barriers were constructed between 1940 and 1944, meaning the rates are double that stated. Block ships that were scuttled in deep water before WW2 have been submerged by accreting sand for decades and are now found buried within the interior of the dunes. Such was the rate of accretion of sand that Orkney Council used the interior of the dunes as a sand quarry for many years.

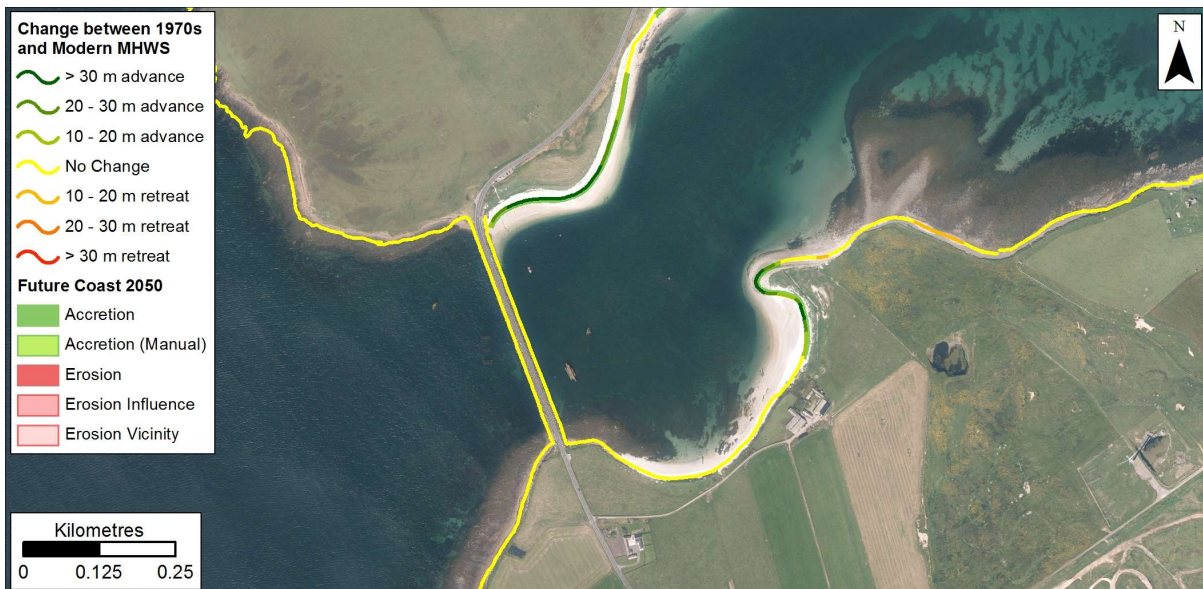
Figure 10.15: Possible future coastline position in 2050 based on rates between 1970 and Modern MHWS data at Churchill Barrier No. 3. Getmapping are our current providers of Scotland-wide digital aerial imagery© Getmapping plc.

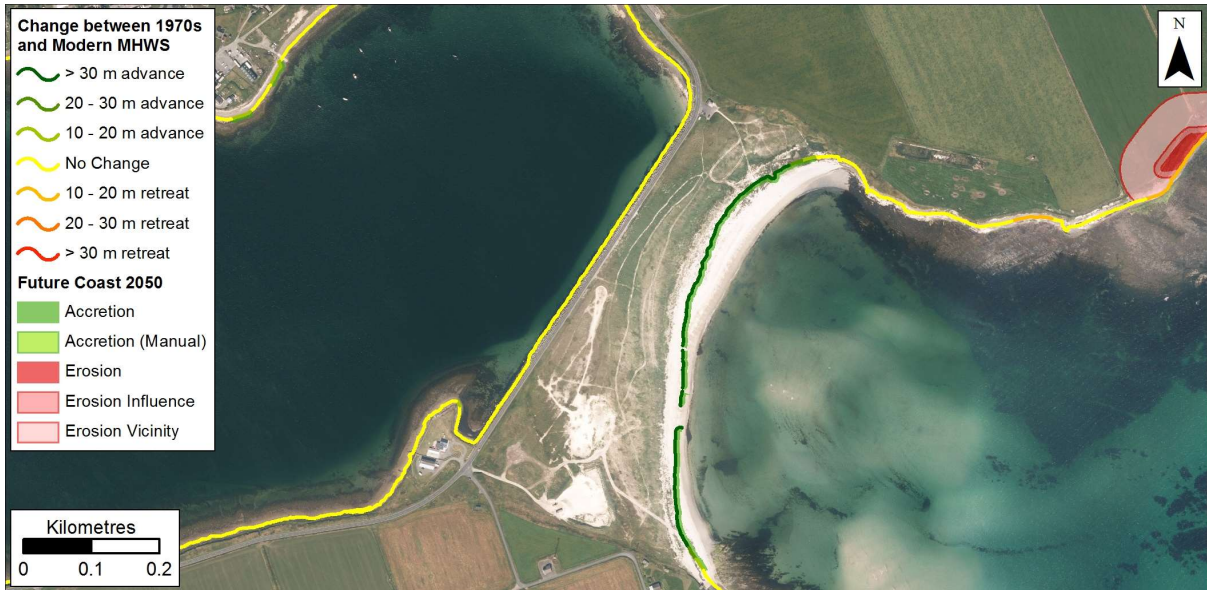
Figure 10.16: Possible future coastline position in 2050 based on rates between 1970 and Modern MHWS data Churchill Barrier No. 4. Getmapping are our current providers of Scotland-wide digital aerial imagery© Getmapping plc.

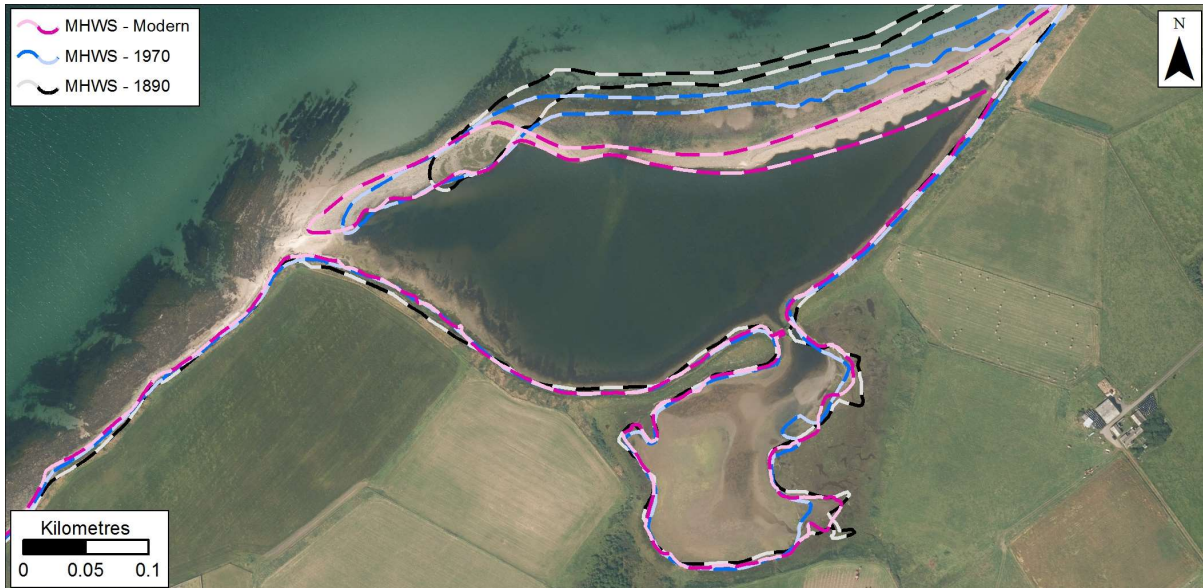
Figure 10.17: MHWs position in 1890, 1970s, and Modern datasets at Long Ayre. Getmapping are our current providers of Scotland-wide digital aerial imagery© Getmapping plc.

Historic Change: Long Ayre is a 700 m gravel spit that extended west by 80 m between 1900 and 1964 (1.3 m/yr), enclosing a lagoon (Figure 10.17). Up to 37 m of erosion (0.5 m/yr) at the eastern (proximal) end of the spit fuels accretion of the westward (distal) end. Since 1964, modest changes have occurred (less than 10 m on the open coast:) but the southward movement continues at its eastern end with the distal end extending west by 15 m over 46 years (0.3 m/yr). The lagoon is not yet fully enclosed and there is tidal exchange at its western end as well as overwash during stormy conditions.

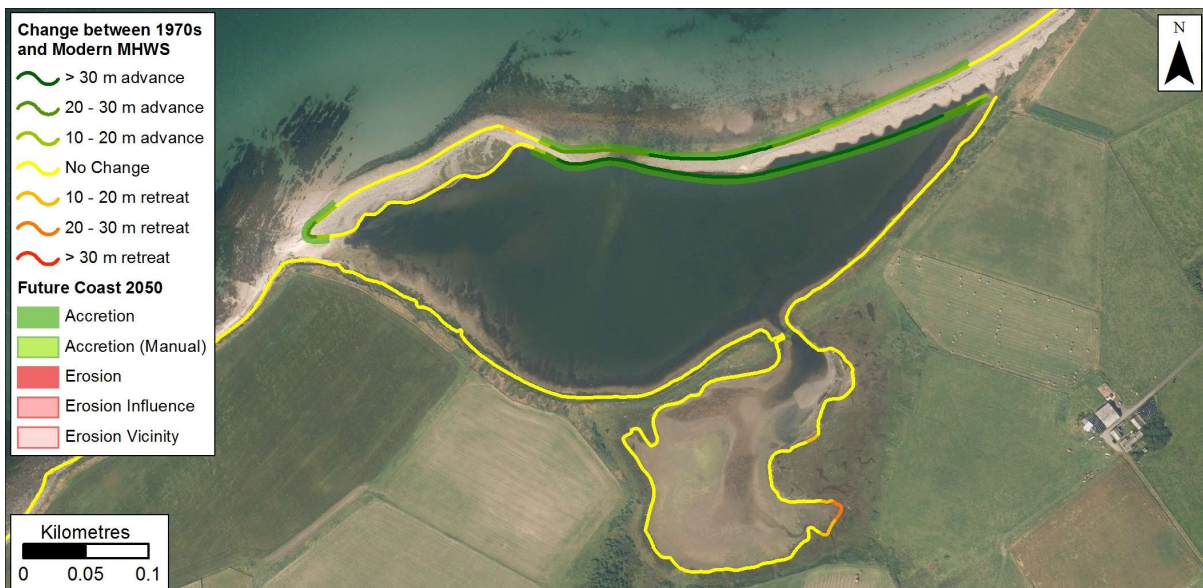
Figure 10.18: Possible future coastline position in 2050 based on rates between 1970 and Modern MHWs data at Long Ayre. Getmapping are our current providers of Scotland-wide digital aerial imagery© Getmapping plc.

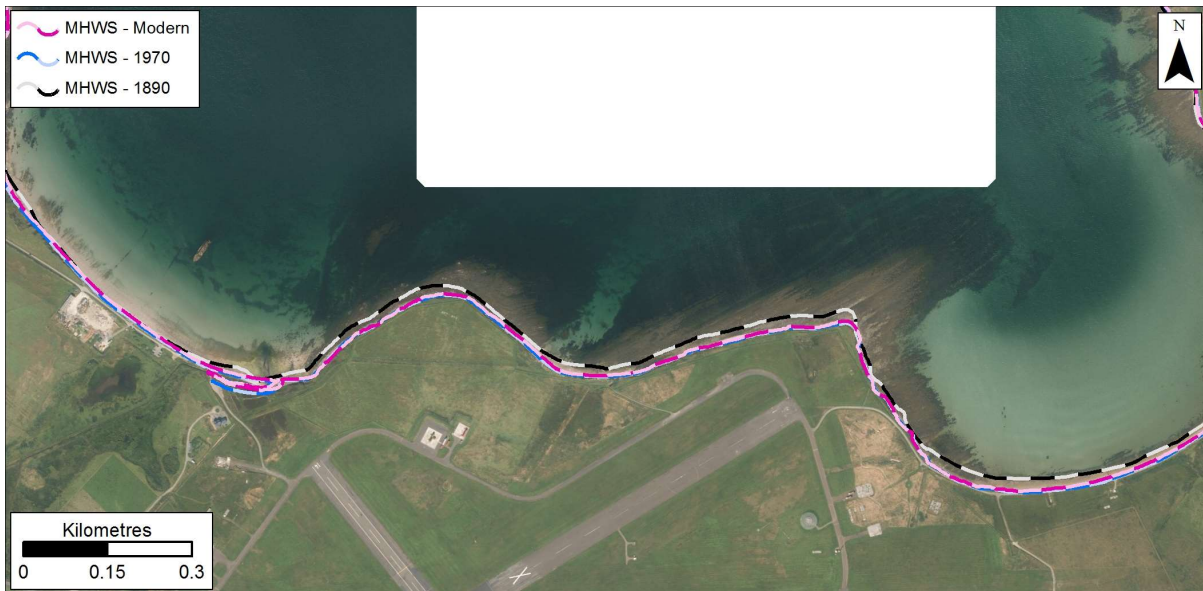
Figure 10.19: Possible future coastline position in 2050 based on rates between 1970 and Modern MHWs data at the Sands of Essonquoy and the Sands of Wideford. Getmapping providers of Scotland-wide digital aerial imagery© Getmapping plc.

Future Vulnerability: The latest MHWs line is the same as in 1968 so ‘no change’ has occurred here. Minor roads run along this stretch of shore and give cause for concern over the medium to long term.

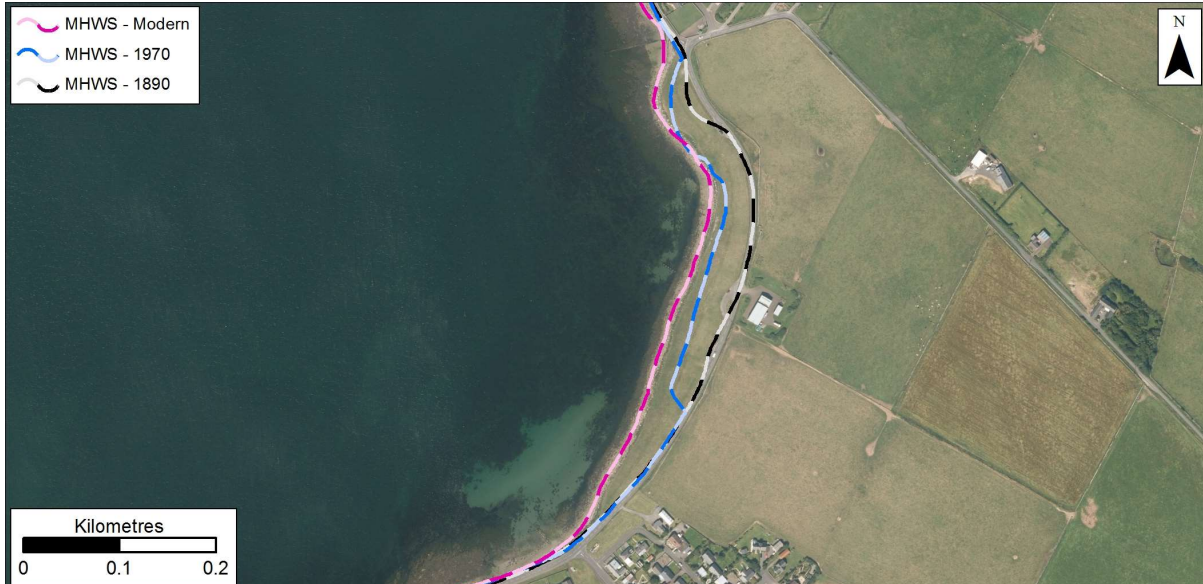
Figure 10.21: MHWS position in 1890, 1970s, and Modern datasets at the Bay of Weyland. Getmapping are our current providers of Scotland-wide digital aerial imagery© Getmapping plc.

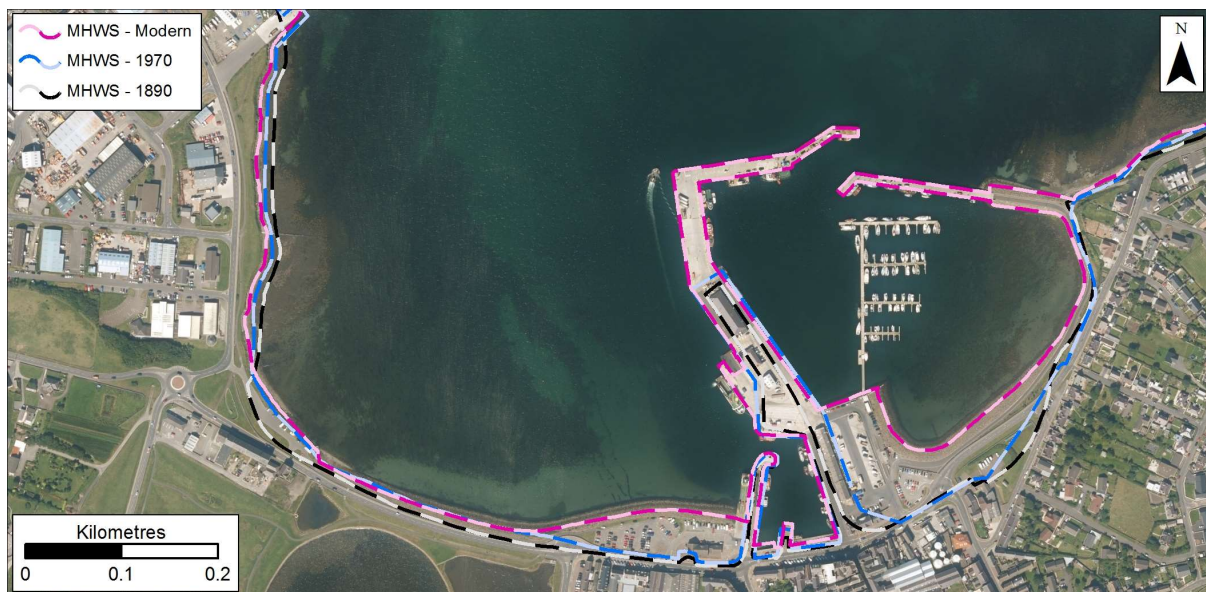
Figure 10.23: MHWS position in 1890, 1970s, and Modern datasets at Kirkwall. Getmapping are our current providers of Scotland-wide digital aerial imagery © Getmapping plc.

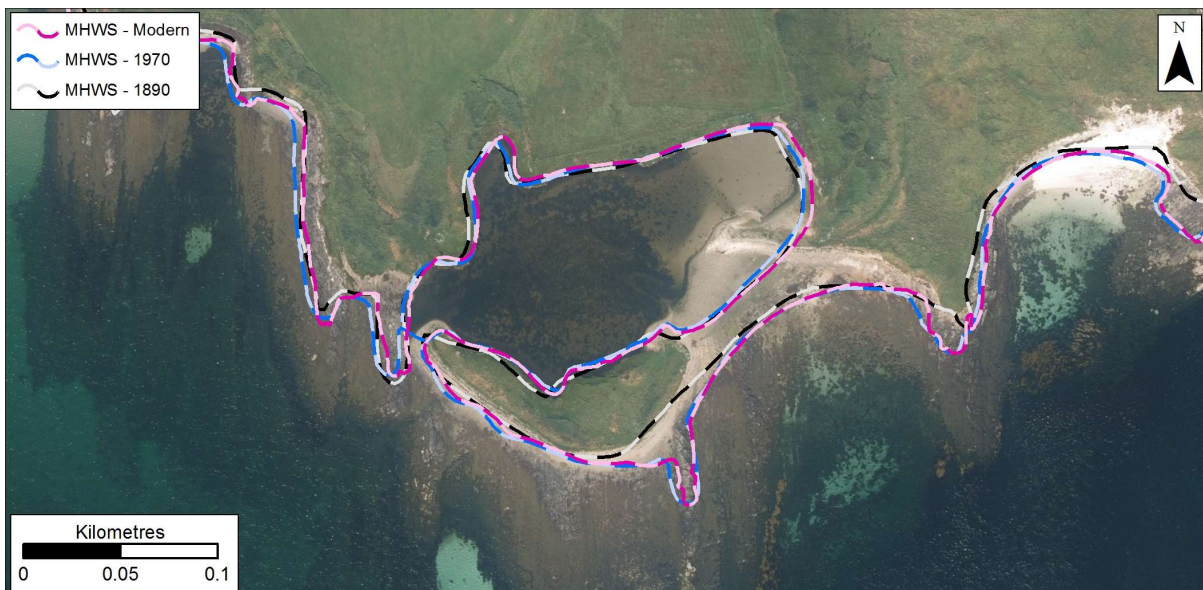
Figure 10.25: MHWS position in 1890, 1970s, and Modern datasets at Mae Sand. Getmapping are our current providers of Scotland-wide digital aerial imagery© Getmapping plc.

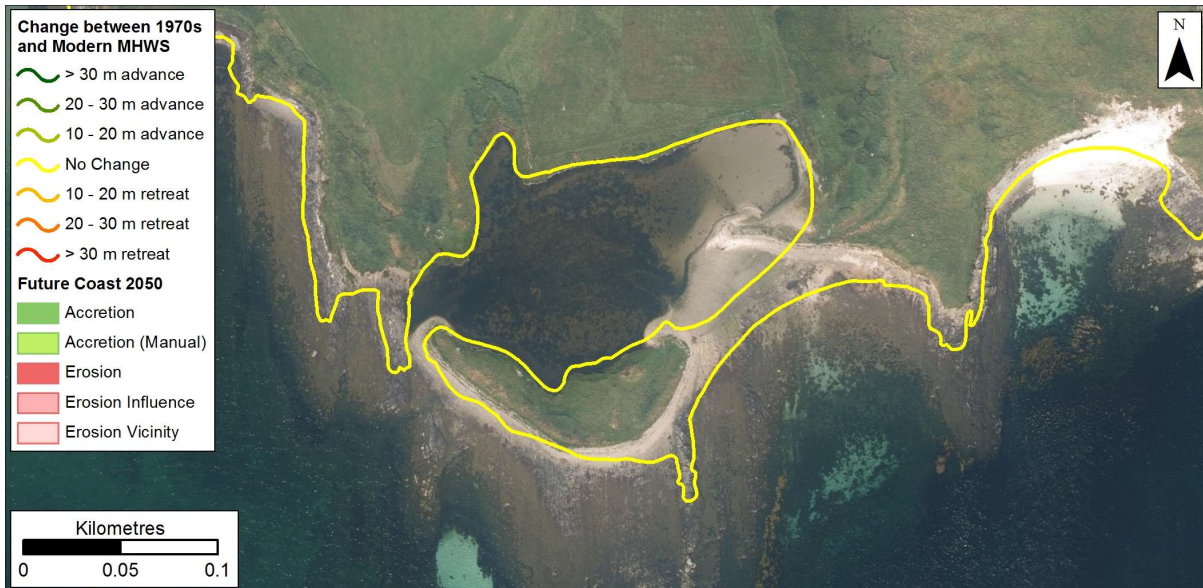
Figure 10.26: Possible future coastline position in 2050 based on rates between 1970 and Modern MHWS data at Mae Sand. Getmapping are our current providers of Scotland-wide digital aerial imagery© Getmapping plc.

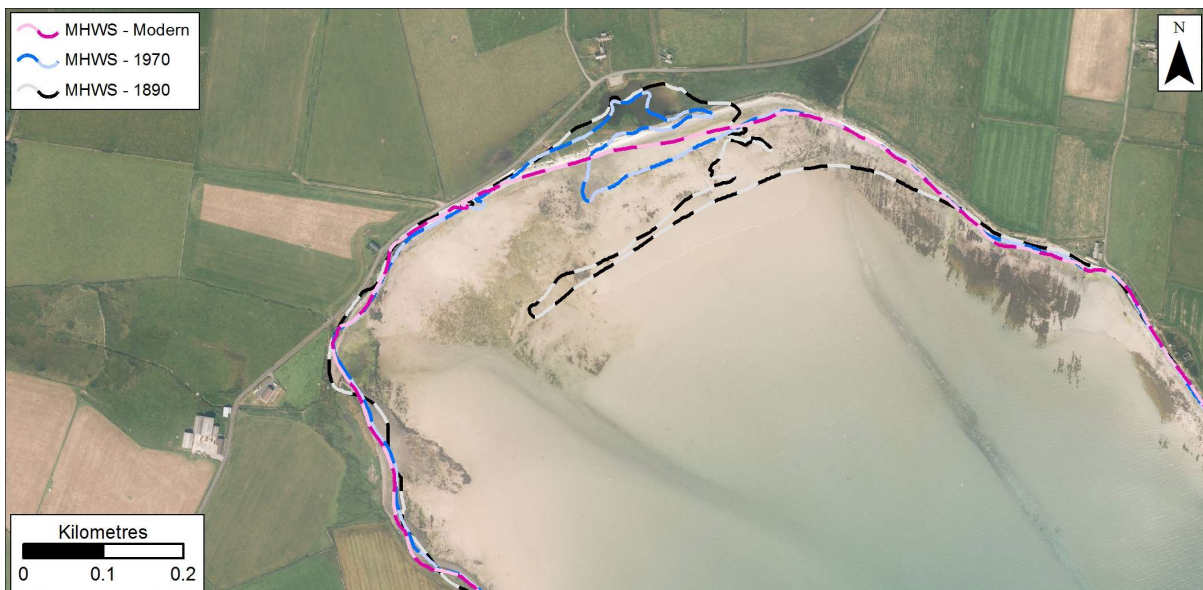
Figure 10.27: MHWS position in 1890, 1970s, and Modern datasets at the Bay of Tuquoy. Getmapping are our current providers of Scotland-wide digital aerial imagery© Getmapping plc.

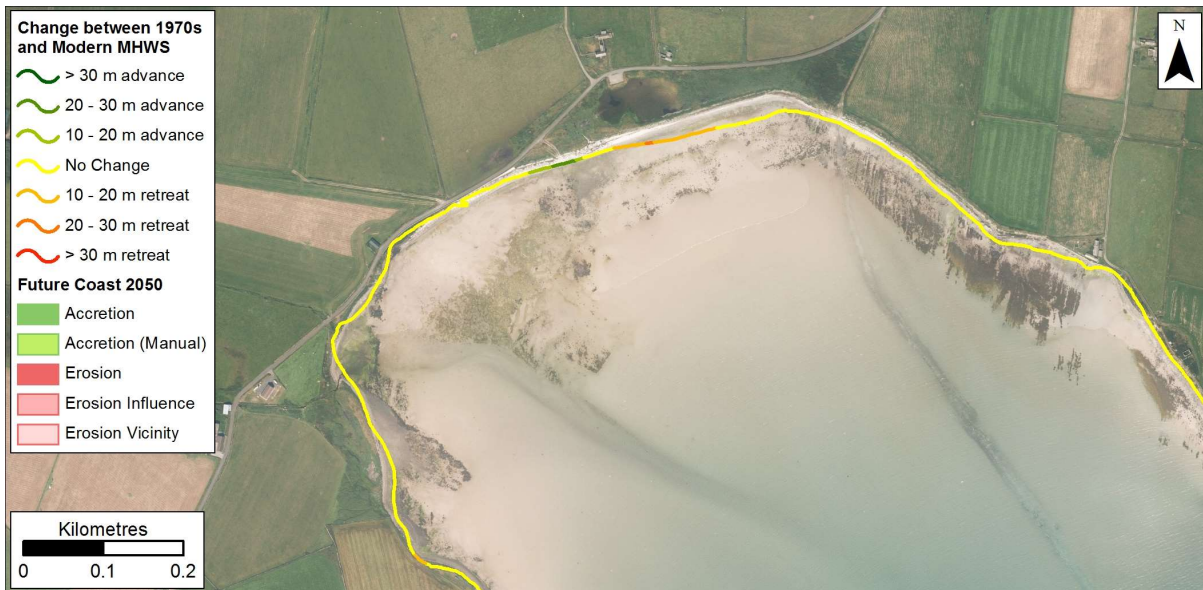
Figure 10.28: Possible future coastline position in 2050 based on rates between 1970 and Modern MHWS data at the Bay of Tuquoy. Getmapping are our current providers of Scotland-wide digital aerial imagery© Getmapping plc.

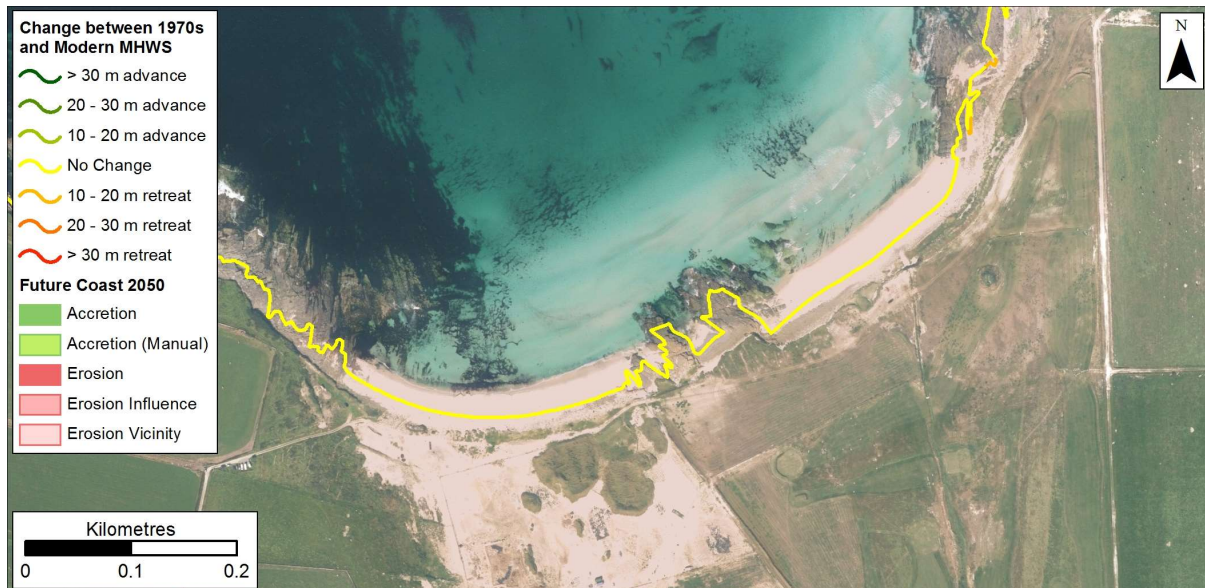
Figure 10.30: Possible future coastline position in 2050 based on rates between 1970 and Modern MHWS data at the Links of Notland. Getmapping are our current providers of Scotland-wide digital aerial imagery© Getmapping plc.

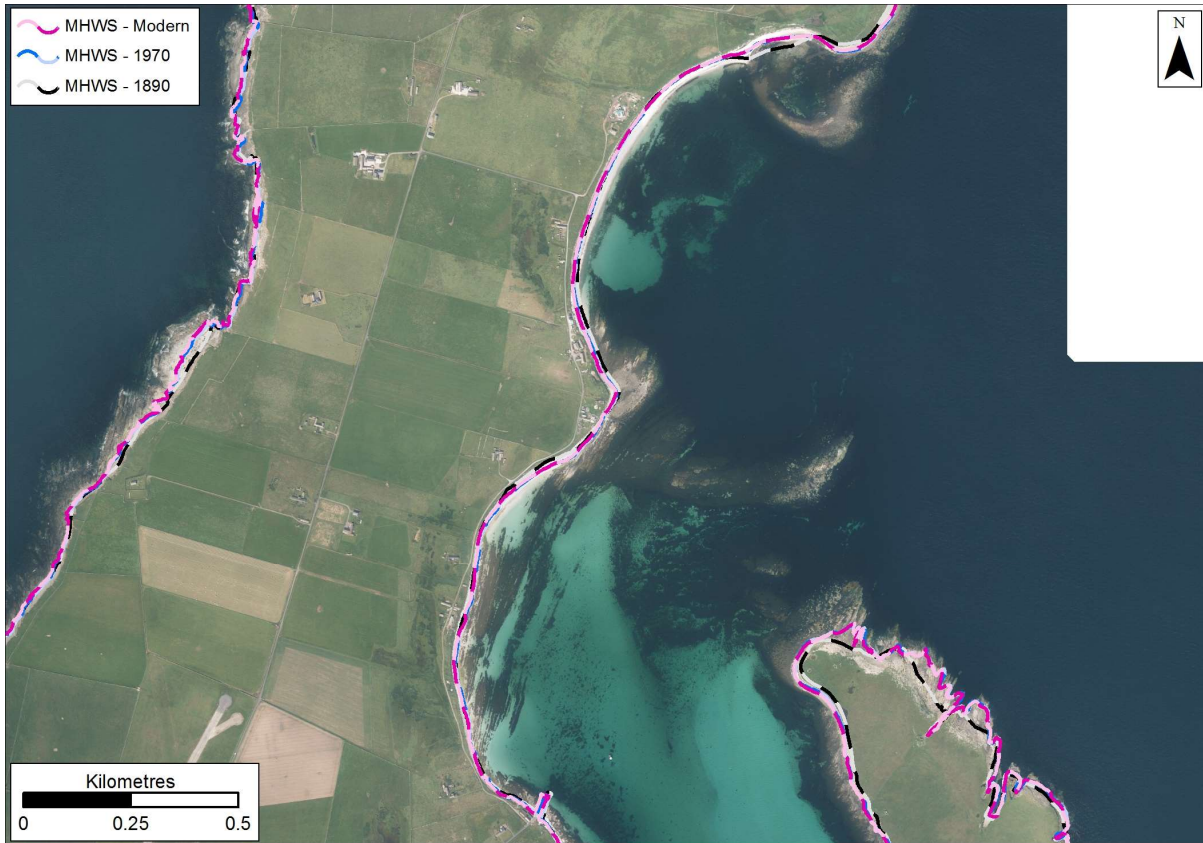
Figure 10.31: MHWS position in 1890, 1970s, and Modern dataset on Papa Westray. Getmapping are our current providers of Scotland-wide digital aerial imagery © Getmapping plc.

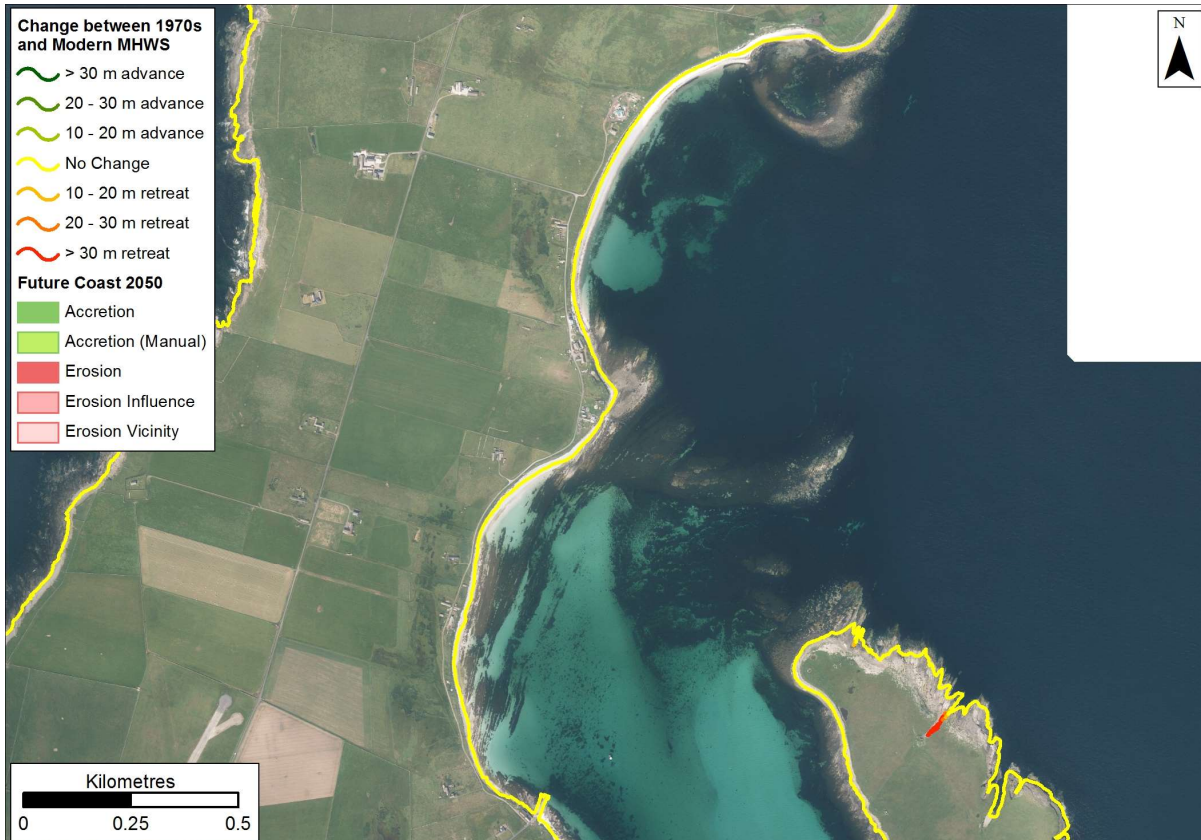
Figure 10.32: Possible future coastline position in 2050 based on rates between 1970 and Modern MHWS data on Papa Westray. Getmapping are our current providers of Scotland-wide digital aerial imagery © Getmapping plc.

Future Vulnerability: As the the latest MHWS line is the same as the 1975 MHWS position, ‘no change’ is recorded at this location (Figure 10.32). Nevertheless, the modern aerial photography shows that recession continues and the viability of the road that parallels the coast and provides access to the coastal properties that lie on both sides of the road is vulnerable in places and is a cause for concern in the future.
