Dynamic Coast - National Coastal Change Assessment: Cell 10 - Orkney

Dynamic Coast – Scotland's National Coastal Change Assessment

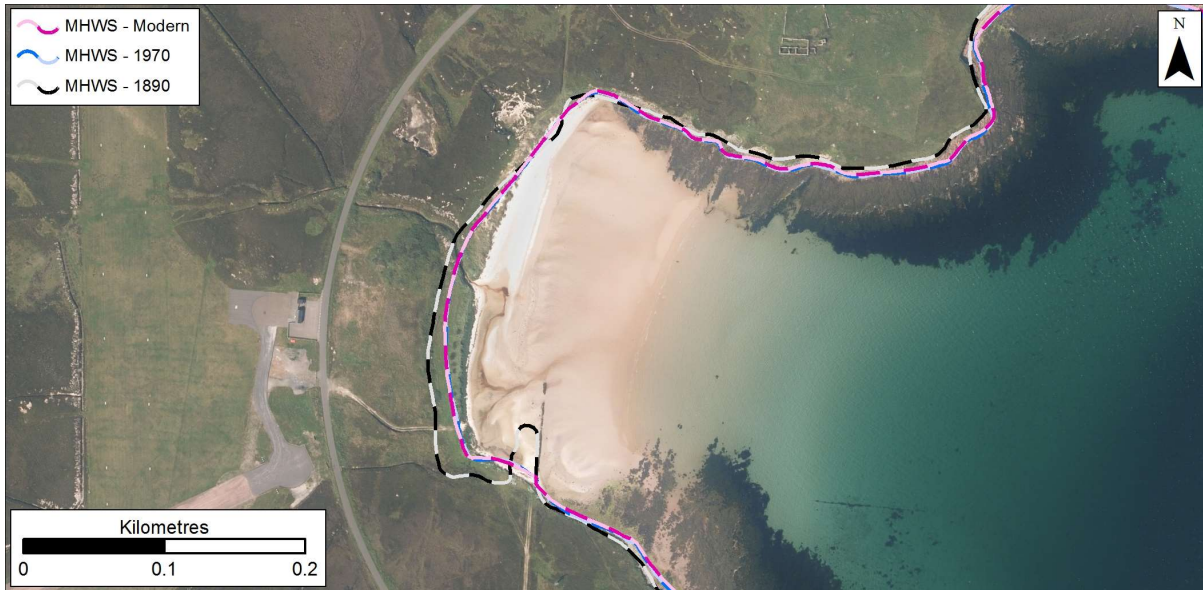
Figure 10.33: MHWs position in 1890, 1970s, and Modern datasets at the Bay of London. Getmapping are our current providers of Scotland-wide digital aerial imagery© Getmapping plc.

Historic Change: At the Bay of London (Figure 10.33) on the east side of Eday there has been up to 10m accretion since 1900 and 1971. Prior to that the roadway crossed the bay on a causeway that has been eroded before 1900 but whose traces remain. Over the modern period some 8m of accretion has occurred in the bay centre, according to the OS MHWS. However in reality, 28m of accretion is shown by the photography although this does taper away to zero at the north and south ends.

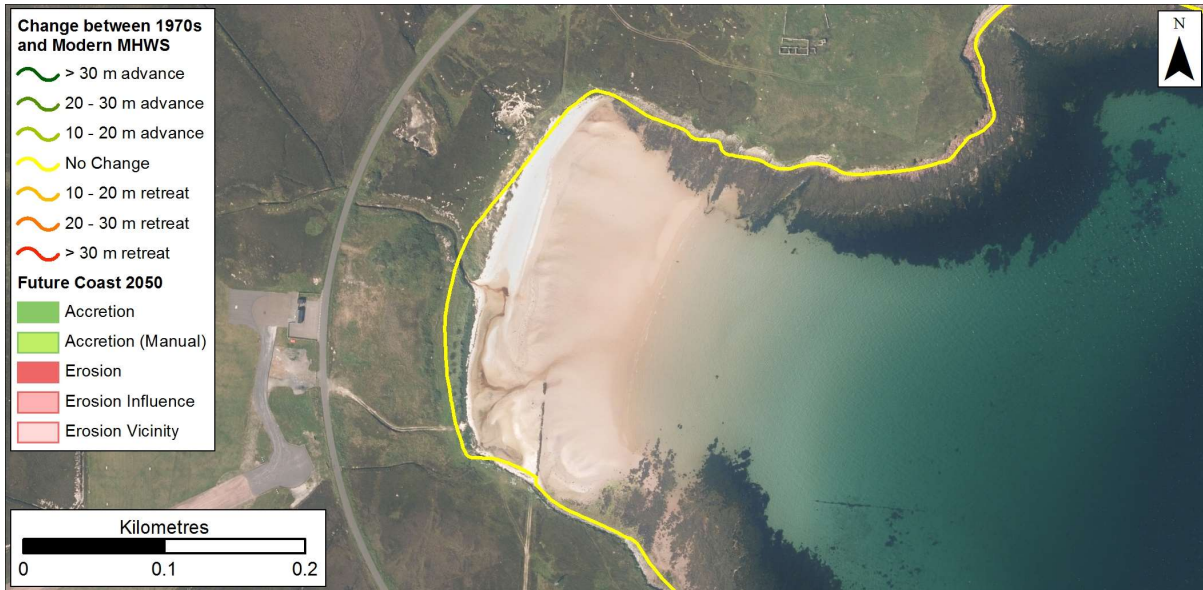
Figure 10.35: Possible future coastline position in 2050 based on rates between 1970 and Modern MHWS data at the Bay of London. Getmapping are our current providers of Scotland-wide digital aerial imagery© Getmapping plc.

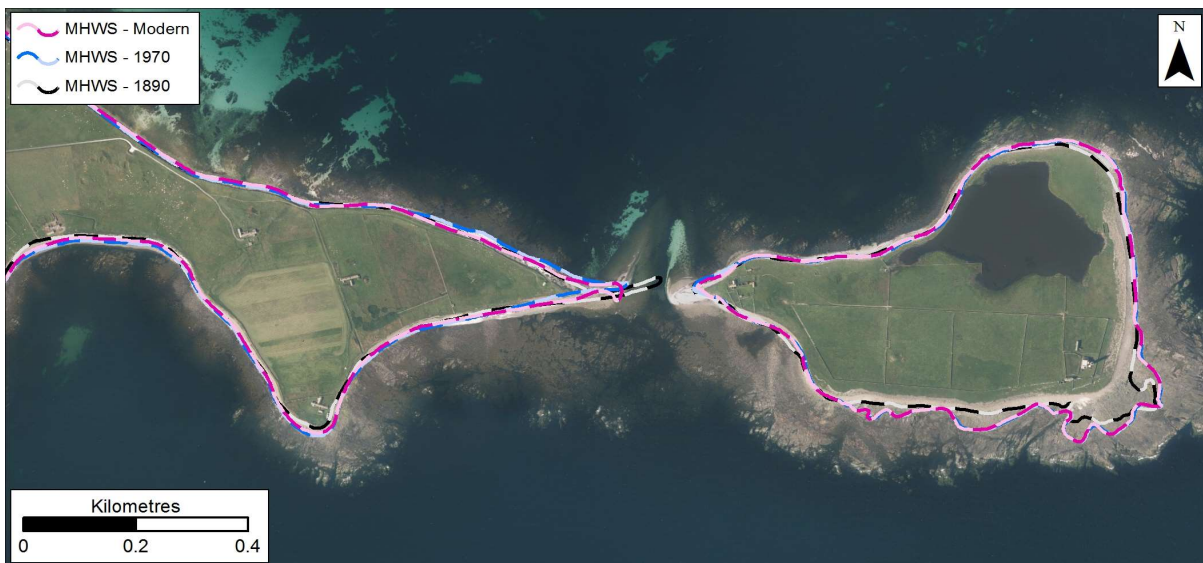
Figure 10.39: MHW position in 1890, 1970s, and Modern datasets at Start Point. Getmapping are our current providers of Scotland-wide digital aerial imagery© Getmapping plc.

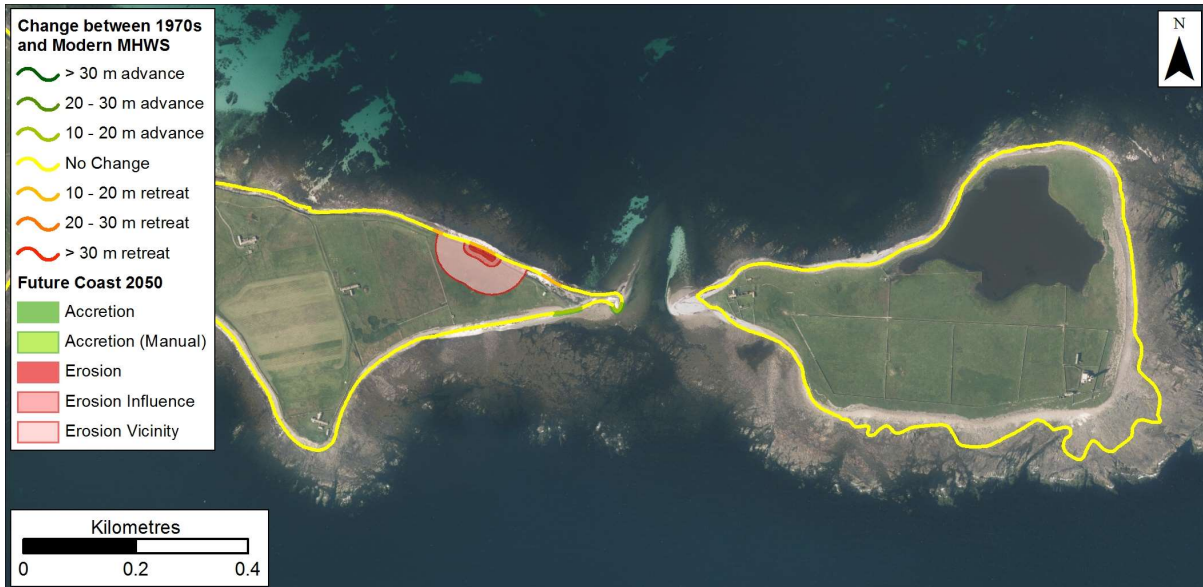
Figure 10.40: Possible future coastline position in 2050 based on rates between 1970 and Modern MHWS data at Start Point. Getmapping are our current providers of Scotland-wide digital aerial imagery© Getmapping plc.

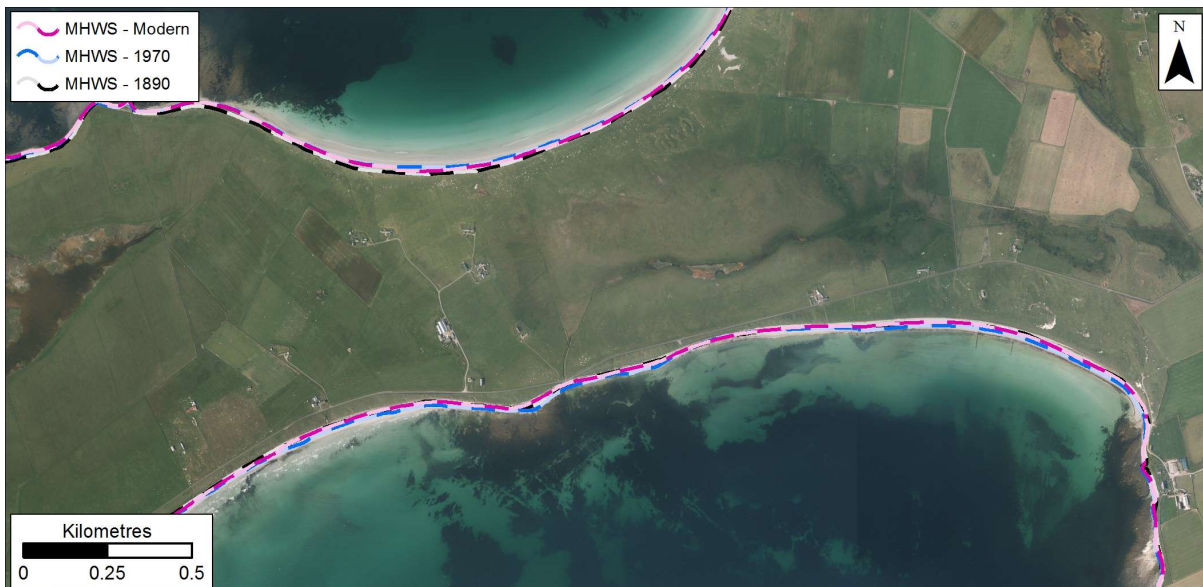
Figure 10.41: MHWS position in 1890, 1970s, and Modern datasets at the Bay of Sandquoy and Lopness. Getmapping are our current providers of Scotland-wide digital aerial imagery© Getmapping plc.

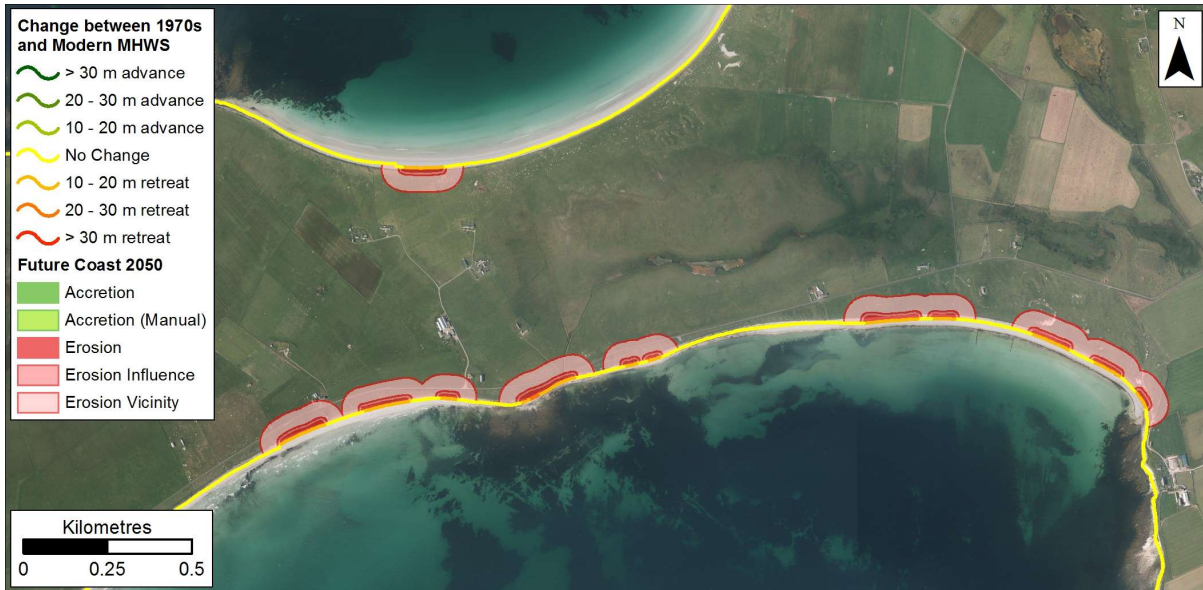
Figure 10.42: Possible future coastline position in 2050 based on rates between 1970 and Modern MHWS data at the Bay of Sandquoy and Lopness. Getmapping are our current providers of Scotland-wide digital aerial imagery © Getmapping plc.

Future Vulnerability: Both beaches are backed by low dunes that give way to a negative gradient inland to very low-lying ground. In Sandquoy, a 130 m length in the centre of the bay is anticipated to erode by another 13 m by 2050, and in the south at Lopness, nine areas covering 2.2 km of the east of the 4.5 km long bay give cause for concern (Figure 10.42). The anticipated erosion affects 150 m of the B9069 at the Loch of Langamay burn exit, and a further 1.2 km lies within the area of erosion vicinity. Given that the dune gradients fall landward then the erosion vicinity overlap onto the road is a real cause for concern. There is further cause for concern if erosion progresses into the future and removes either, or both, of the dune ridges that back both bays and allowing marine incursion into the areas to the rear. This will raise the possibility of the area of Northwall and Tofts Ness becoming separated from mainland Sanday. The B9069 roadway closely parallels the arc of Lopness Bay and in places lies within 2 m of MHWS at the exit of the Loch of Langamay burn, where a short seawall occurs. By 2050 this length of road and the low-lying area behind is anticipated to be vulnerable to erosion and flooding.

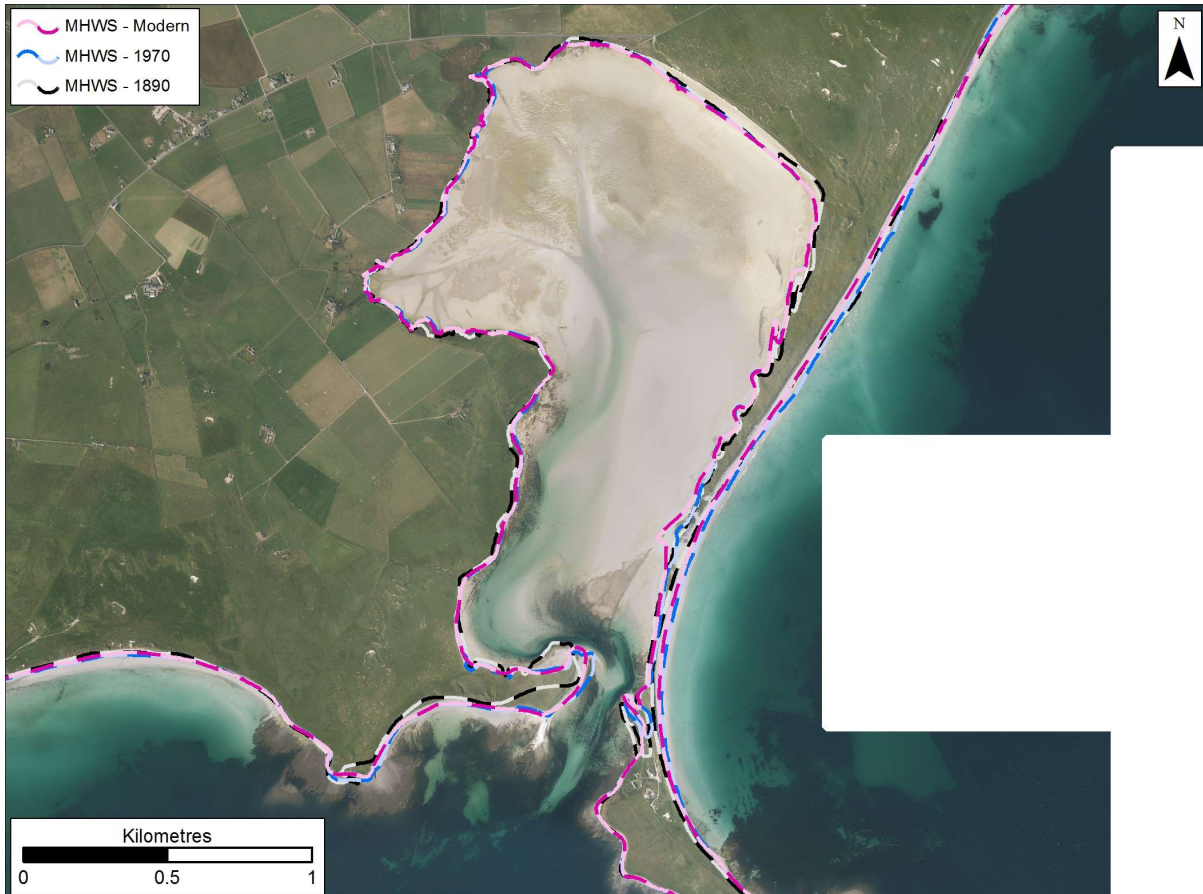
Figure 10.43: MHWS position in 1890, 1970s, and Modern datasets at Cata Sands. Getmapping are our current providers of Scotland-wide digital aerial imagery © Getmapping plc.

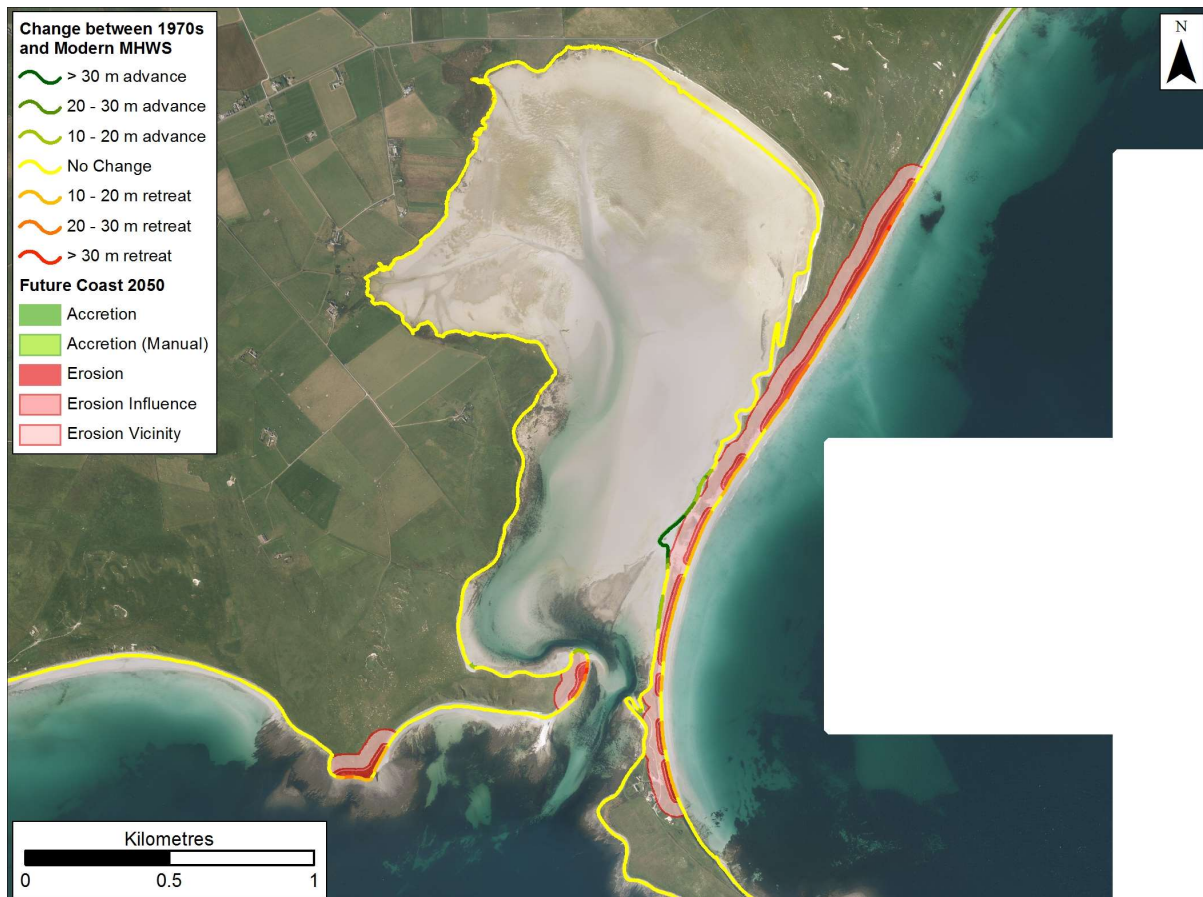
Figure 10.44: Possible future coastline position in 2050 based on rates between 1970 and Modern MHWS data at Cata Sands. Getmapping are our current providers of Scotland-wide digital aerial imagery© Getmapping plc.

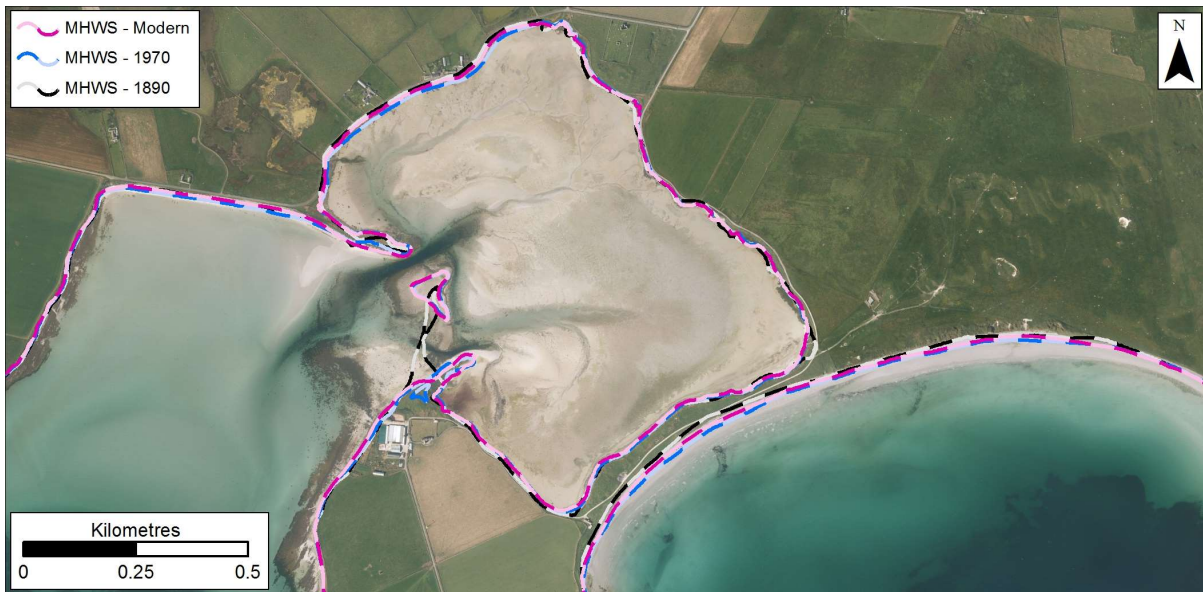
Figure 10.45: MHWS position in 1890, 1970s, and Modern datasets at Little Sea. Getmapping are our current providers of Scotland-wide digital aerial imagery© Getmapping plc.

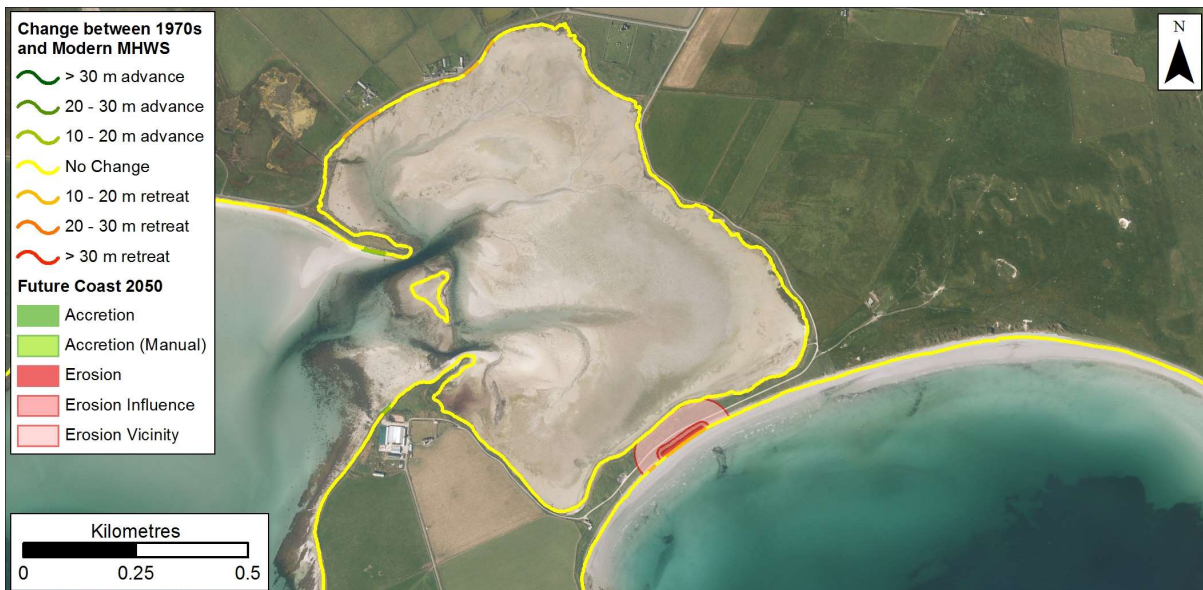
Figure 10.46: Possible future coastline position in 2050 based on rates between 1970 and Modern MHWS data at Little Sea. Getmapping are our current providers of Scotland-wide digital aerial imagery© Getmapping plc

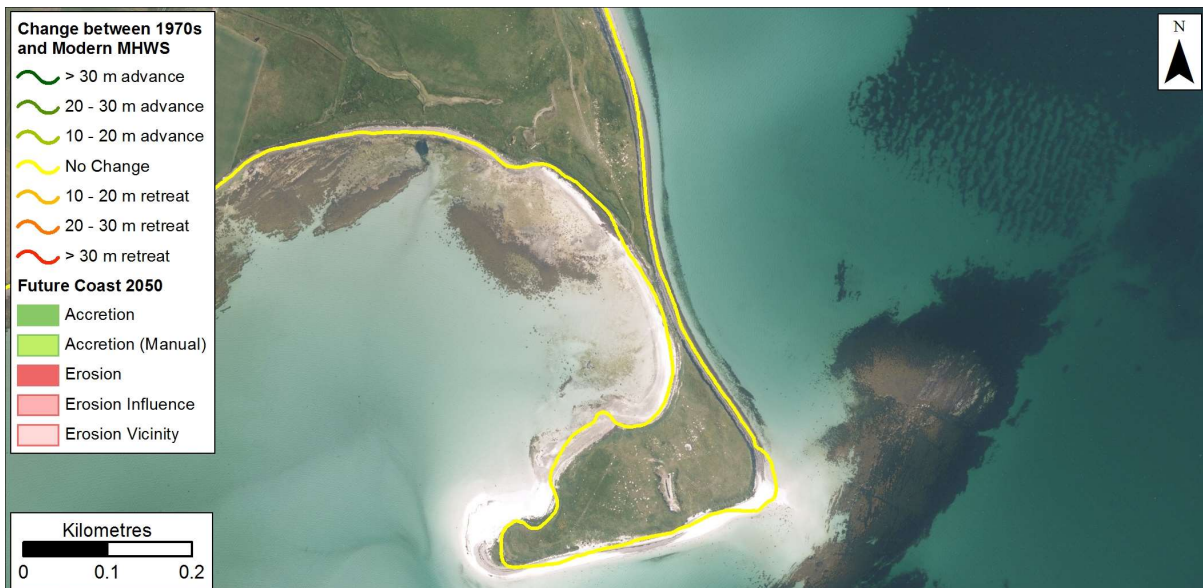
Figure 10.48: Possible future coastline position in 2050 based on rates between 1970 and Modern MHWS data at Otterswick. Getmapping are our current providers of Scotland-wide digital aerial imagery© Getmapping plc.

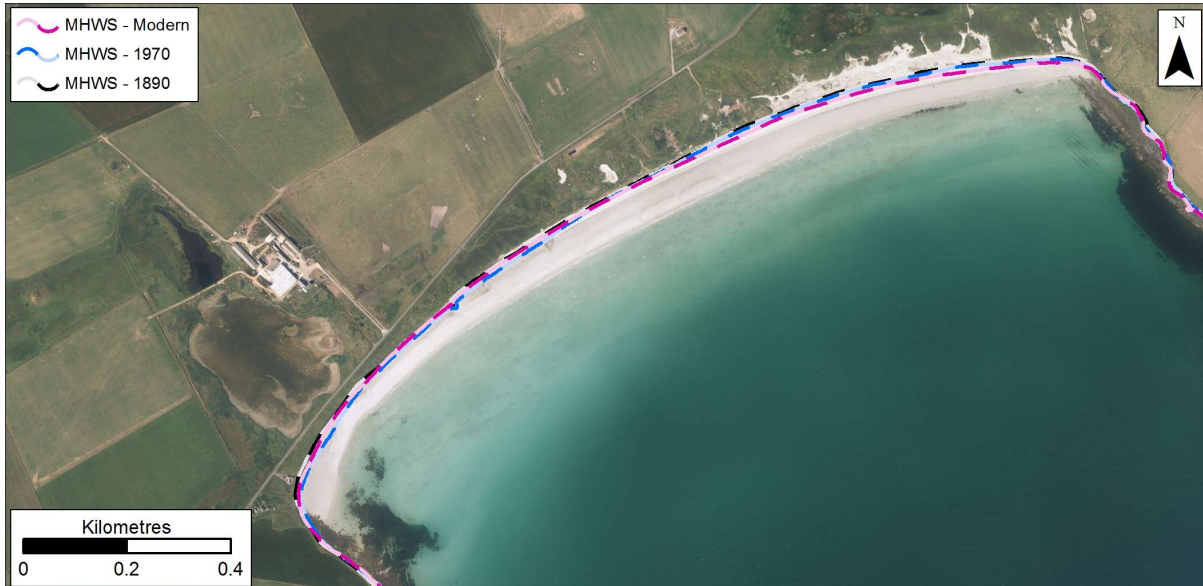
Figure 10.49: MHWS position in 1890, 1970s, and Modern datasets at the Sands of Rothiesholm. Getmapping are our current providers of Scotland-wide digital aerial imagery© Getmapping plc.

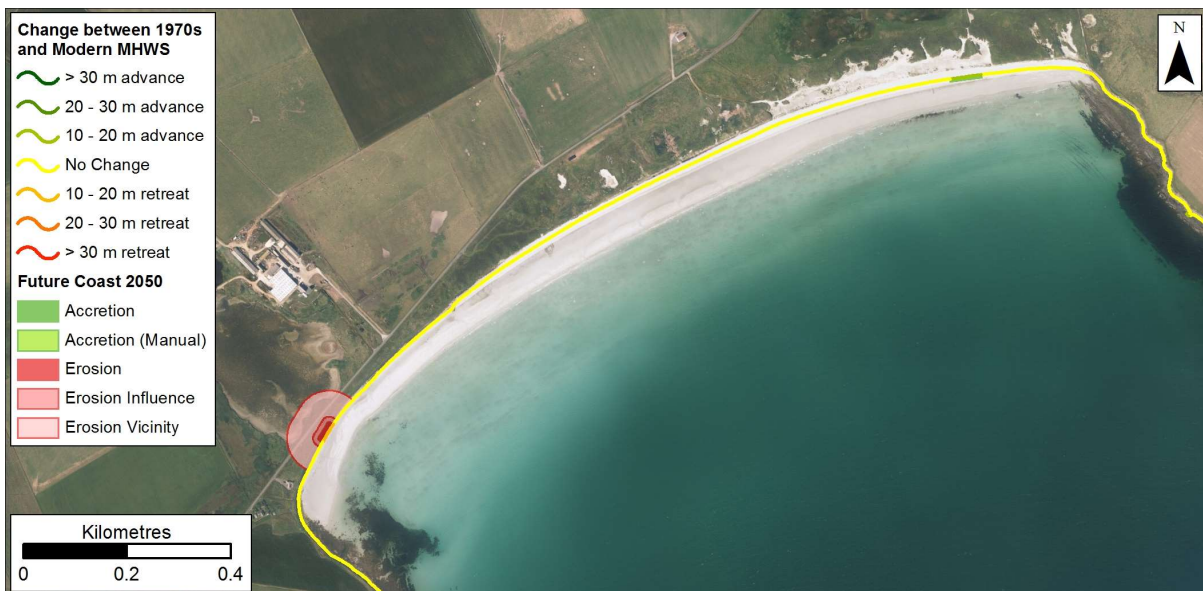
Figure 10.50: Possible future coastline position in 2050 based on rates between 1970 and Modern MHWs data at the Sands of Rothiesholm. Getmapping are our current providers of Scotland-wide digital aerial imagery© Getmapping plc.
