# Dynamic Coast - National Coastal Change Assessment: Cell 3 - Cairnbulg Point to Duncansby Head

## *Dynamic Coast – Scotland's National Coastal Change Assessment*

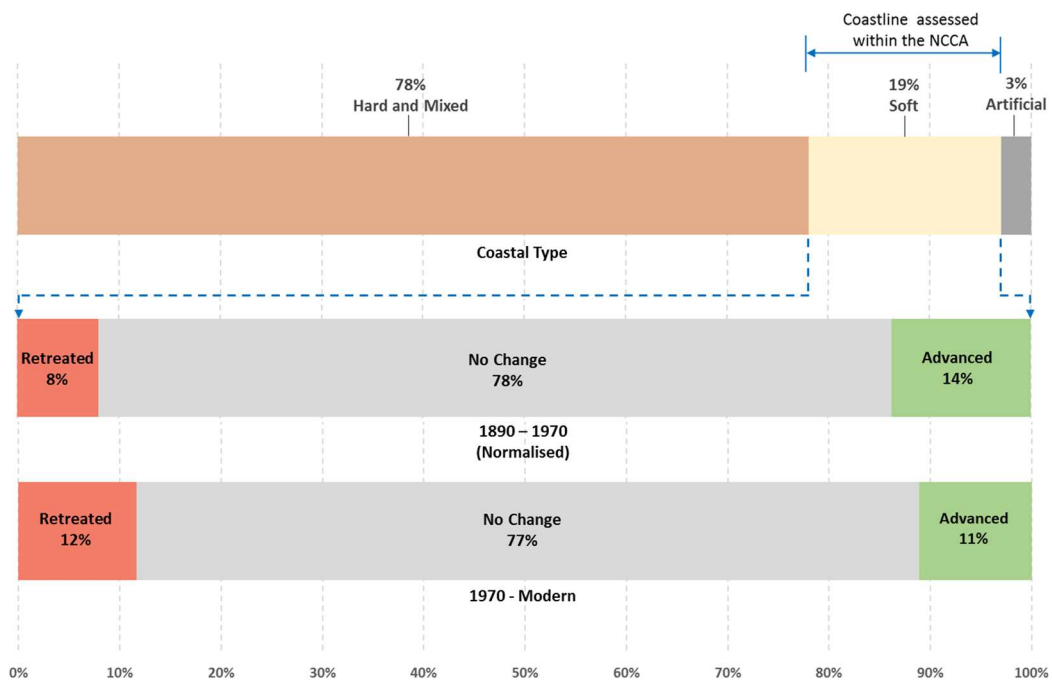
Figure 1: National coastal change results showing the proportion of soft coast retreating, stable and advancing within each change category in the historical (ca. 1890-1970 normalised for time period) and recent (ca. 1970-Present) time periods.

Since the 1970s, 12% of the soft coast length across Scotland has retreated landwards (erosion), 11% has advanced seawards (accretion) and 77% stable or has shown insignificant change (Figure 1). National comparisons from the historical period (1890 to 1970) to recent period (1970-modern), accounting for the different time periods, show an increasing proportion of erosion (8% to 12%), similar stability (from 78% to 77%) and falling accretion (14% to 11%). Where coastal changes occur, they are faster than before. Nationally, average erosion rates after the 1970s have doubled to 1.0 m/yr whilst accretion has almost doubled to 1.5 m/yr.

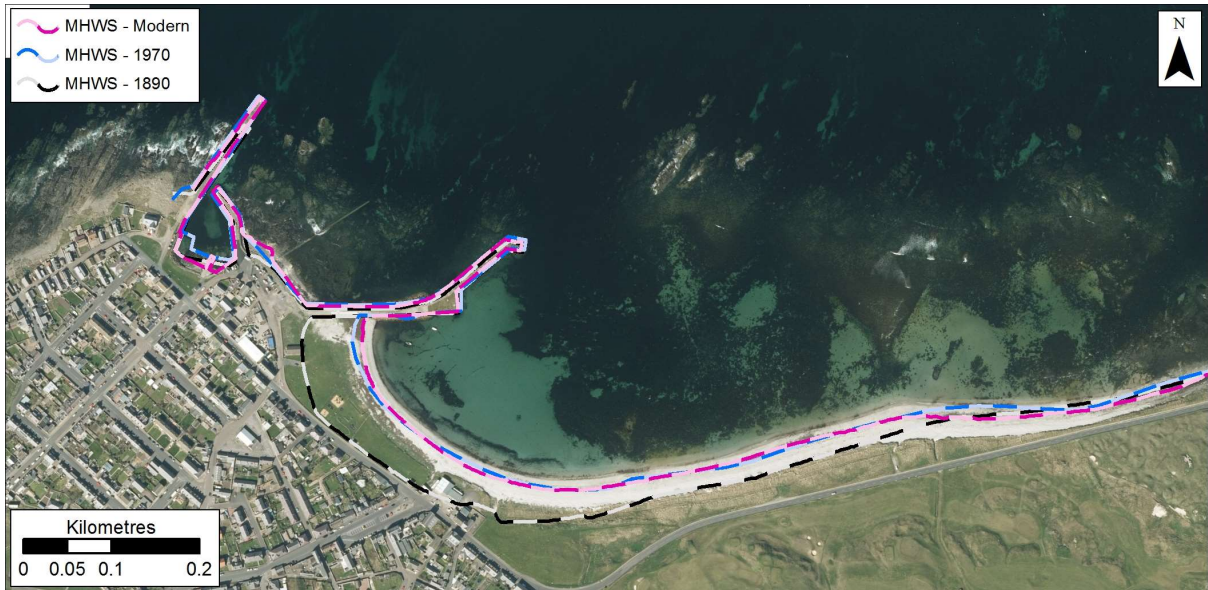
Figure 3.4: MHWs position in 1890, 1970s, and Modern datasets at Rosehearty. Getmapping are our current providers of Scotland-wide digital aerial imagery© Getmapping plc.

**Historic Change:** Rosehearty's eastern pier was in place by 1901 and may have led to up to 60m of accretion to the east up until 1971. Between 1971 and 2011 much of the beach has remained largely stable, apart from its eastern limit, which advanced some 10 m up to 1971 with the present shoreline now landward of its 1901 position (Figure 3.4).

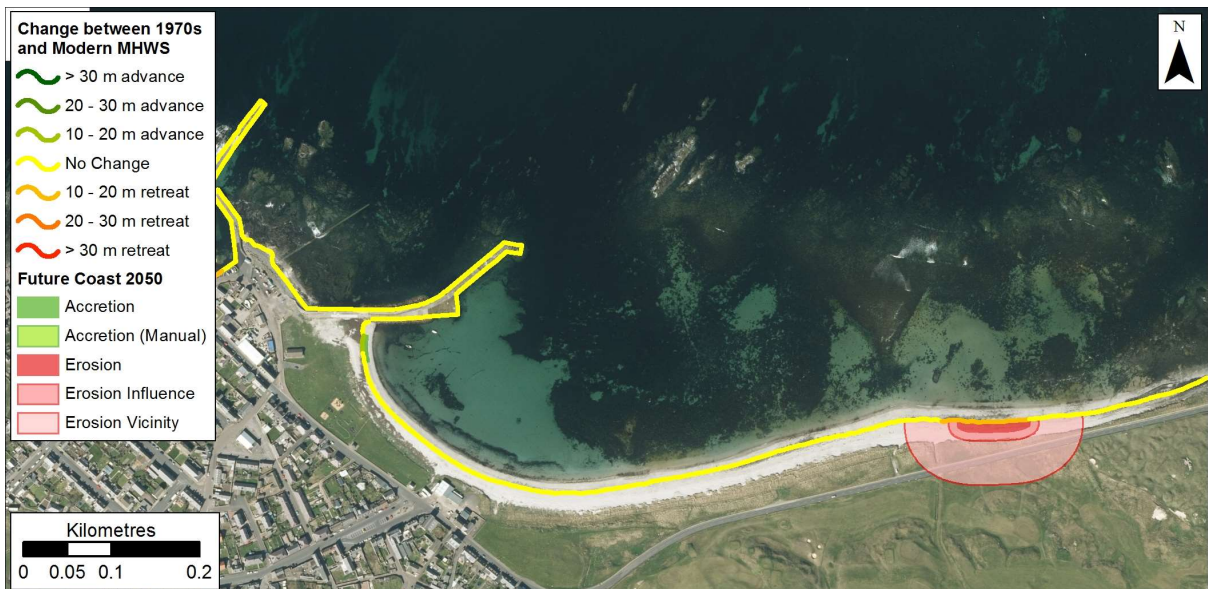
Figure 3.5: Possible future coastline position in 2050 based on rates between 1970 and Modern MHW data at Rosehearty. Getmapping are our current providers of Scotland-wide digital aerial imagery© Getmapping plc.

**Future Vulnerability:** Should the past erosion rates continue at the historical rate, without intervention, the road which runs along the shore (B9031) may be within 21 m of the position of MHWS by 2050 (i.e. erosion vicinity) and within 6m of MHWS by 2100 (i.e. erosion influence) (Figure 3.5). Rosehearty to Fraserburgh Coast Site of Special Scientific Interest (SSSI) occupies the foreshore; any increase in intertidal foreshore may increase the scientific interest of the site. This coast falls within the Fraserburgh and Rosehearty Potentially Vulnerable Area.

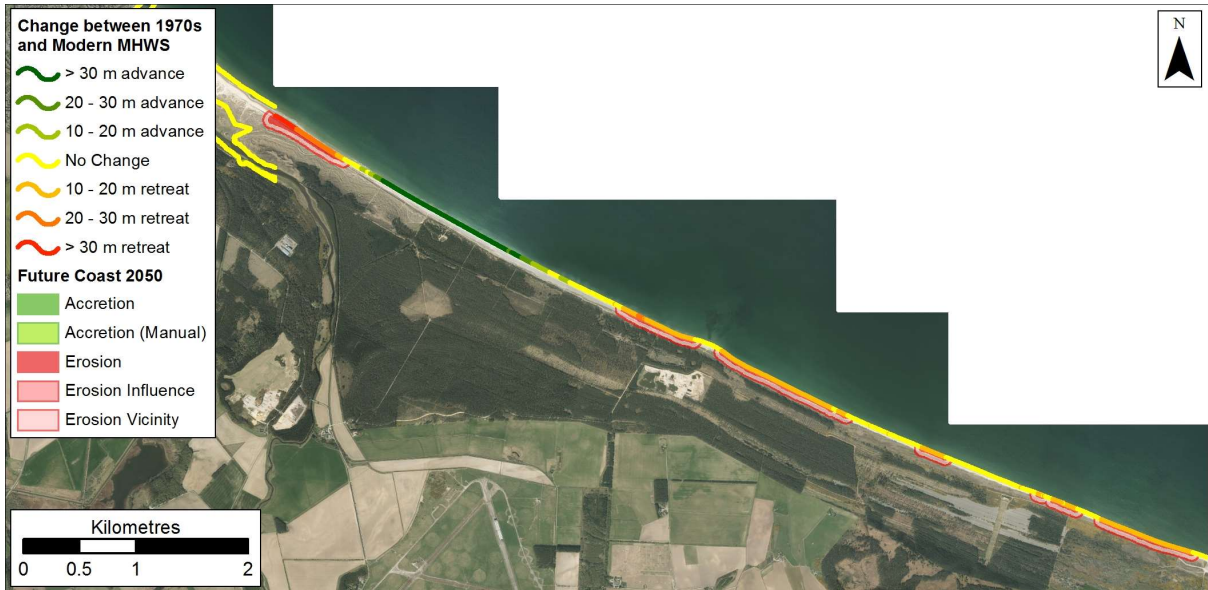
Figure 3.9: Possible future coastline position in 2050 based on rates between 1970 and Modern MHWS data west of the River Spey mouth. Getmapping are our current providers of Scotland-wide digital aerial imagery© Getmapping plc.

westwards towards these assets (Figure 3.9). The recent granting of planning permission for several houses within this recently stable / accretional section of coast, that is likely to become erosional in the future, presents planners with an interesting question – how far ahead should we be looking when implementing planning guidance?

To the west of the river's mouth and beyond Kingston-upon-Spey there are few built structures apart from an MOD rifle firing range which is surrounded by nature conservation designated sites (Special Area of Conservation (SAC) & SSSI). Further westwards within 1.5 km of Lossiemouth the Vulnerability Assessment is incomplete given the lack of useable data to update the inaccurate OS MHWS line. Based on recent air photos the erosion appears to continue in a consistent manner over the last 2 km with between 30 and 50 m of erosion being experienced between 1966 and 2003. Sediments are visibly extending around the harbour and headland at Lossiemouth, which is evidently a leaky sub-cell boundary. This westerly leakage of sediment from Spey Bay means that, despite updrift erosion supplying sediment to these beaches, this sediment transits through and in future erosion is likely to continue.

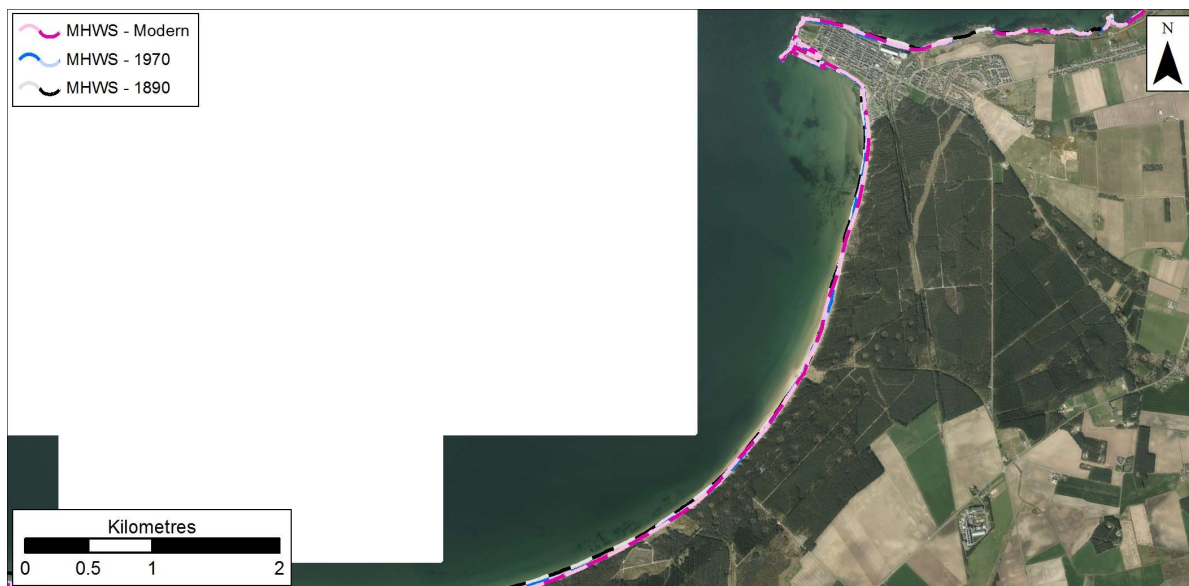
Figure 3.10: MHW position in 1890, 1970s, and Modern datasets south of Burghead. Getmapping are our current providers of Scotland-wide digital aerial imagery © Getmapping plc.

Since 1969 erosion has occurred from the caravan park to the south of Burghead which extends some 700m (Figure 3.10). Beyond this section, the shoreline has remained largely stable for the next 3.7 km with little changes between 1969 and 2011. Erosion starts to dominate along the shoreline in front of RAF Kinloss (Figure 3.11), which has experienced losses between 15 and 25 m over the 42 years (max rate of 0.6 m/yr). The recent erosion continues to within vicinity of the beach car park, where stability and some accretion has occurred (up to 18 m between 1969 and 2011, 0.5 m/yr). A proportion of the sediments released from the erosion in the remainder of the bay have contributed to the westerly movement of the spit at the mouth of the River Findhorn, with a consequential effect on the easternmost dunes at Culbin Sands. Air photographs show extensive sand banks crossing the mouth of the River Findhorn and linking up with the intertidal and subtidal areas adjacent to Culbin Sands. The very modest foreshore gains at the eastern end of Findhorn beach are dwarfed by the substantial and long-lived retreat which has occurred across much of the bay since 1904.

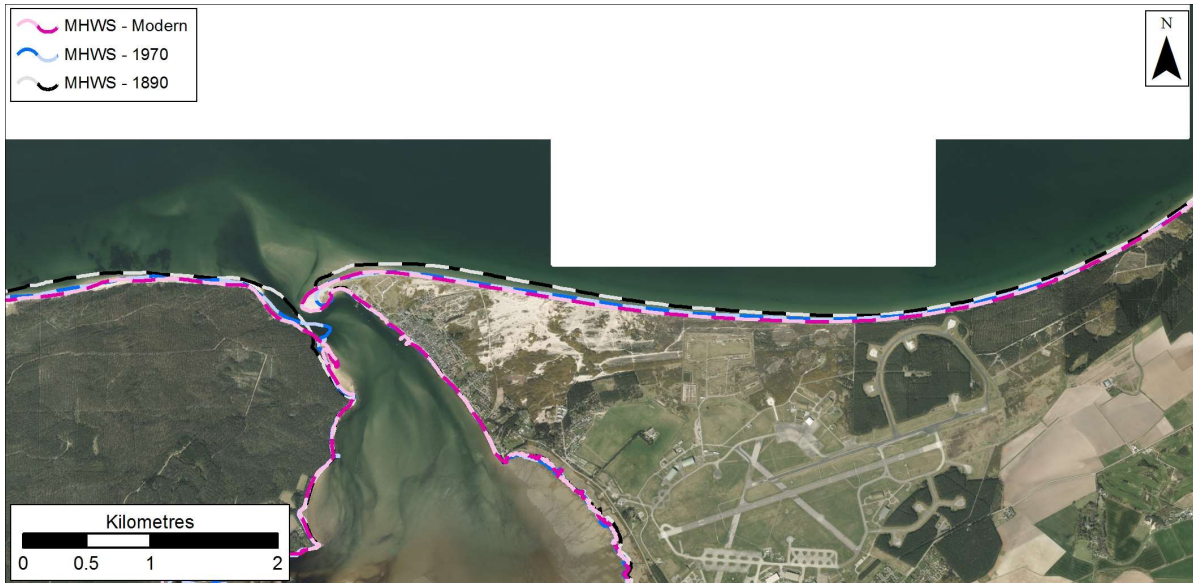
Figure 3.11: MHWS position in 1890, 1970s, and Modern datasets at Findhorn. Getmapping are our current providers of Scotland-wide digital aerial imagery© Getmapping plc.

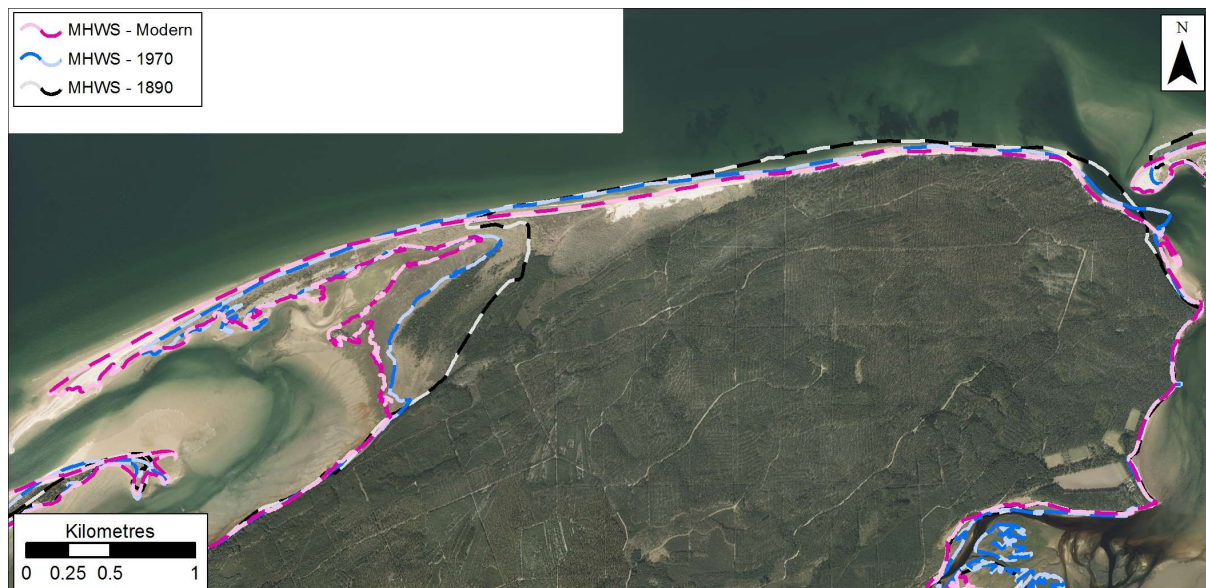
Figure 3.13: MHWS position in 1890, 1970s, and Modern datasets at Culbin Sands. Getmapping are our current providers of Scotland-wide digital aerial imagery © Getmapping plc.

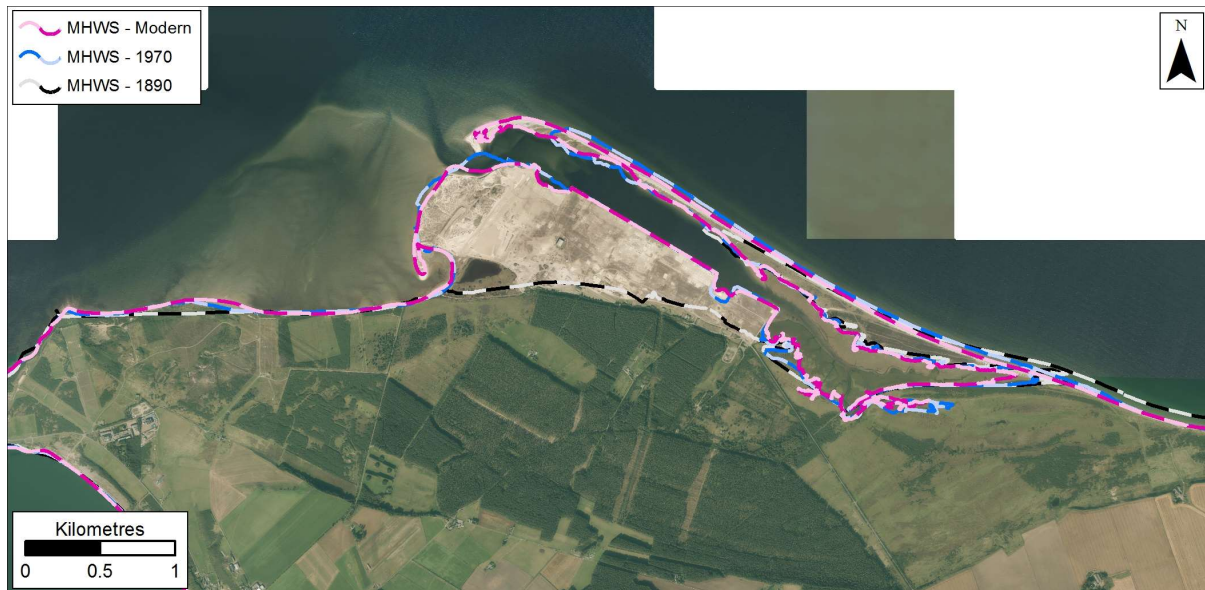
Figure 3.17: MHWS position in 1890, 1970s, and Modern datasets at Whiteness Head. Getmapping are our current providers of Scotland-wide digital aerial imagery © Getmapping plc.

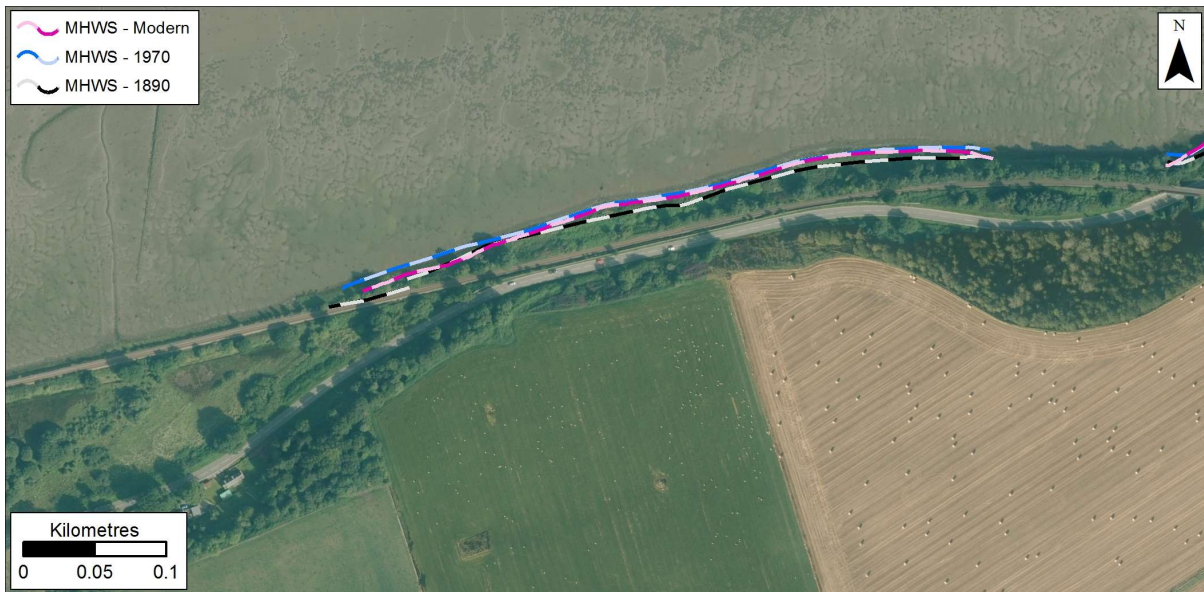
Figure 3.19: MHW position in 1890, 1970s, and Modern datasets on the south bank of the Beaully Firth. Getmapping are our current providers of Scotland-wide digital aerial imagery© Getmapping plc.

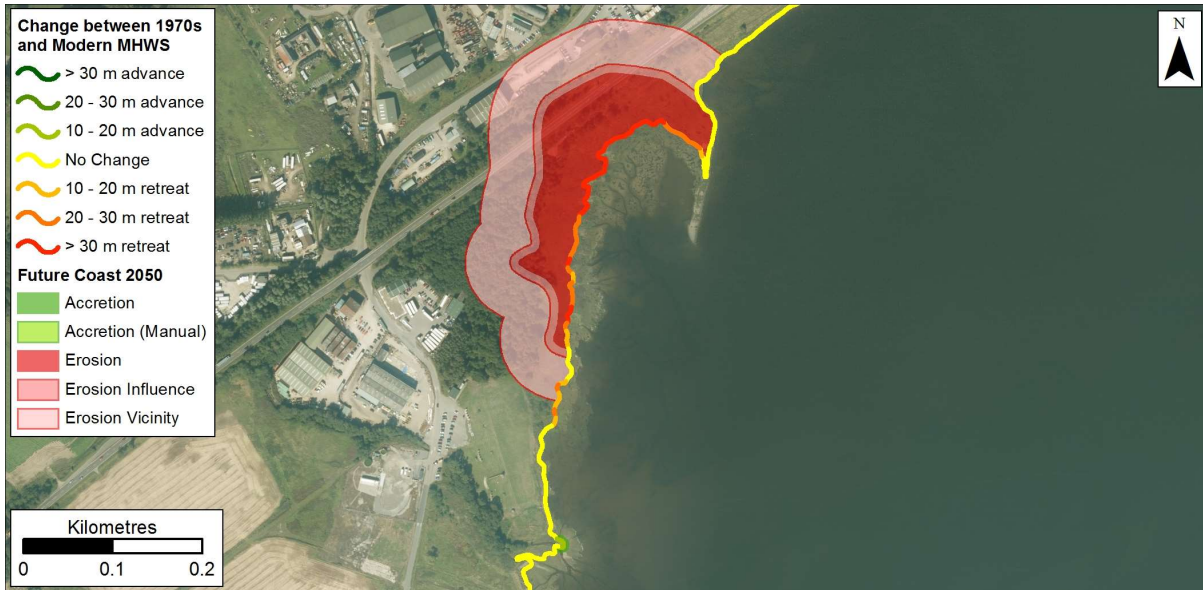
Figure 3.22: Possible future coastline position in 2050 based on rates between 1970 and Modern MHWS data near Culcairn in the Cromarty Firth. Getmapping are our current providers of Scotland-wide digital aerial imagery© Getmapping plc.

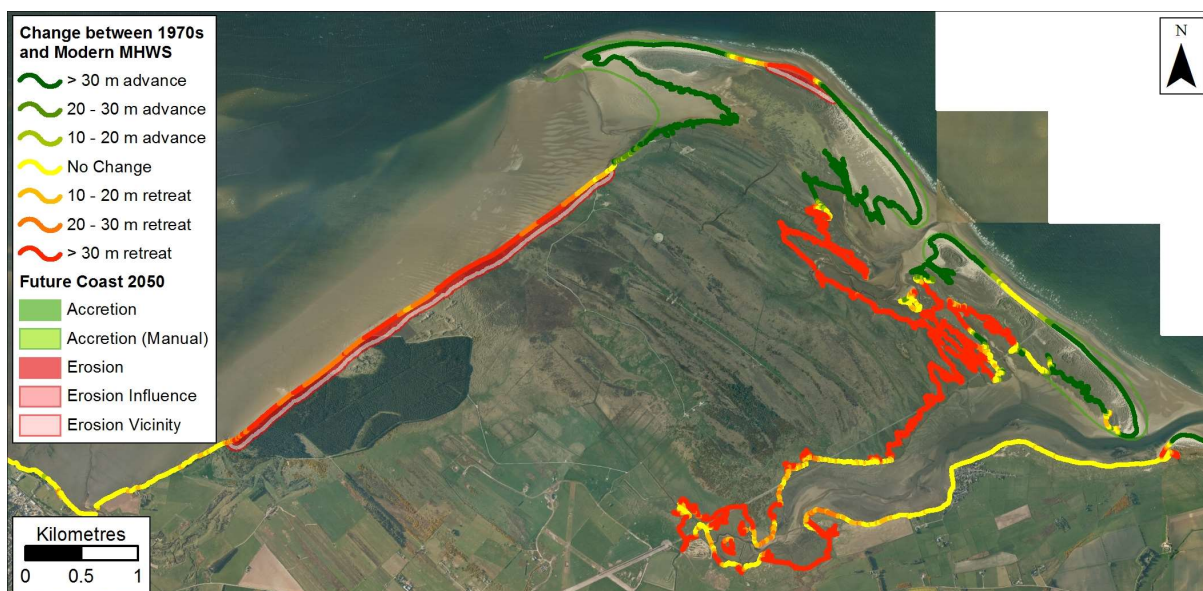
Figure 3.25: Possible future coastline position in 2050 based on rates between 1970 and Modern MHWS data at Morrich More. Getmapping are our current providers of Scotland-wide digital aerial imagery© Getmapping plc.

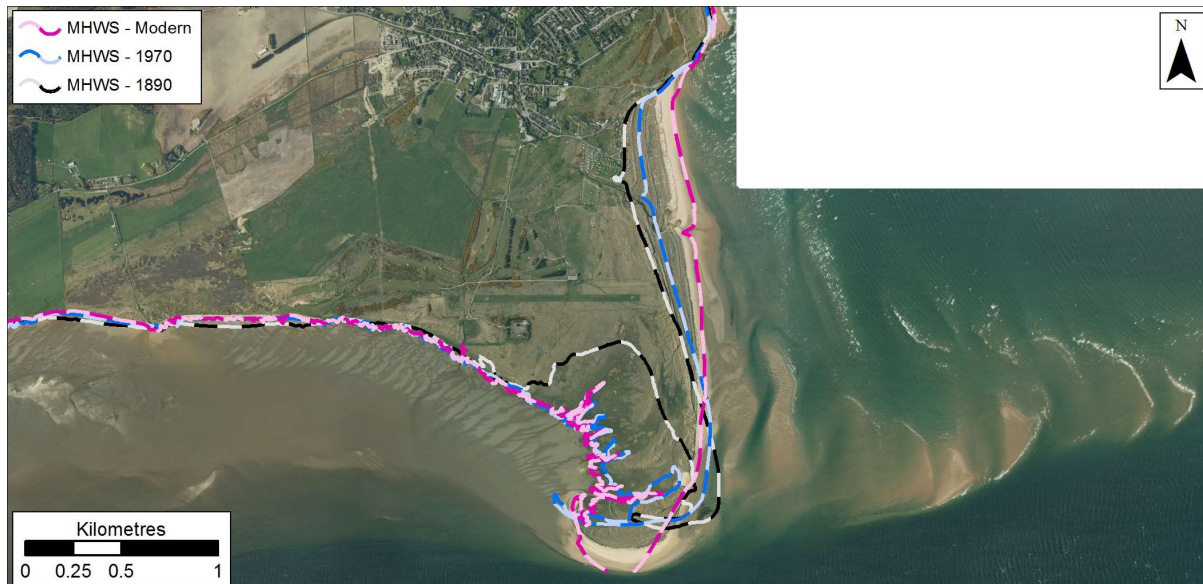
Figure 3.26: MHWS position in 1890, 1970s, and Modern datasets at Dornoch Point. Getmapping are our current providers of Scotland-wide digital aerial imagery © Getmapping plc.

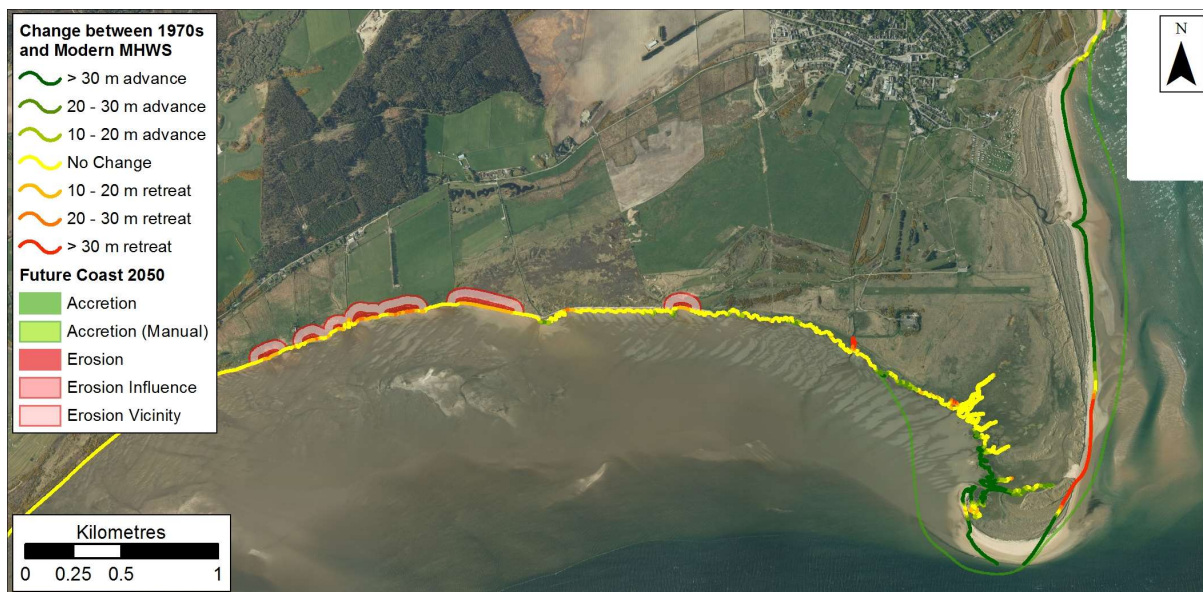
Figure 3.27: Possible future coastline position in 2050 based on rates between 1970 and Modern MHWS data at Dornoch Point. Getmapping are our current providers of Scotland-wide digital aerial imagery© Getmapping plc.

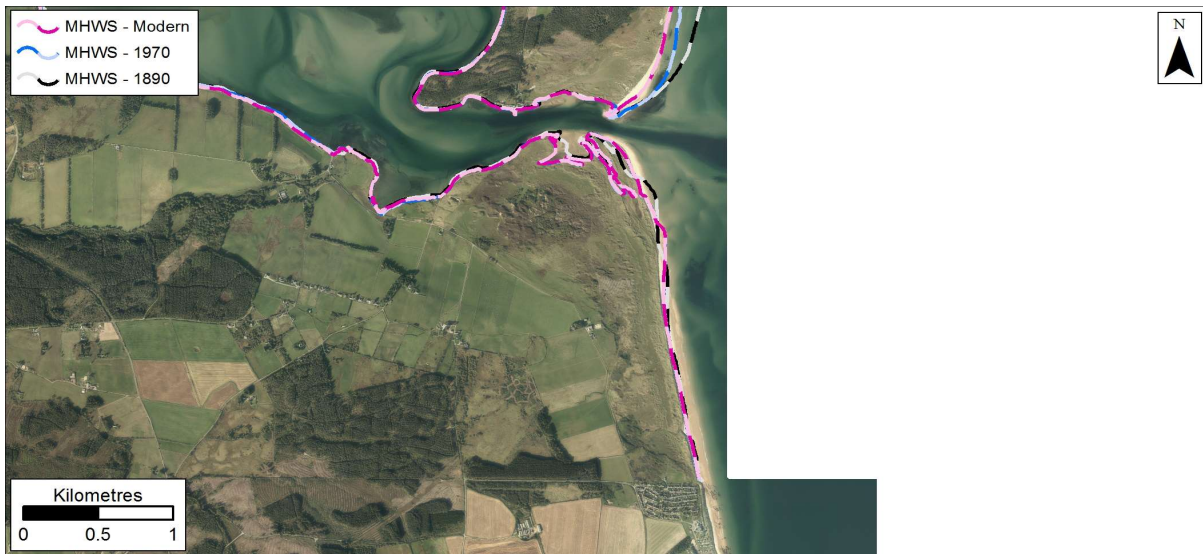
Figure 3.28: MHWS position in 1890, 1970s, and Modern datasets at Coul Links. 1970 MHWS line is obscured by the Modern MHWS line as it has not been updated recently. Getmapping are our current providers of Scotland-wide digital aerial imagery© Getmapping plc.

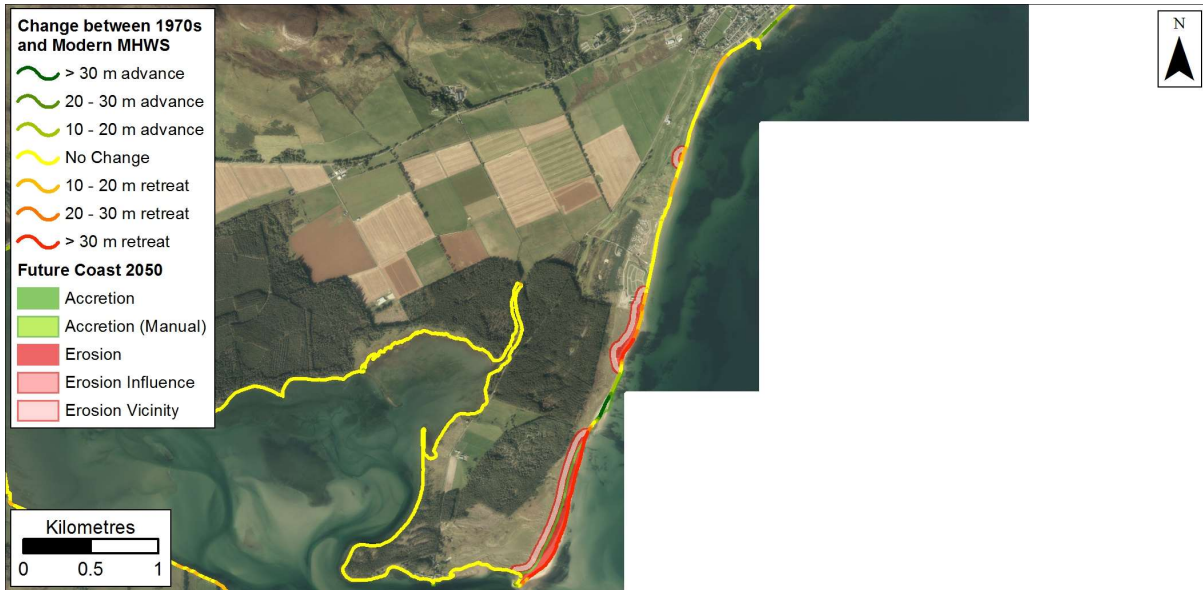
Figure 3.31: Possible future coastline position in 2050 based on rates between 1970 and Modern MHWS data at Golspie. Getmapping are our current providers of Scotland-wide digital aerial imagery© Getmapping plc.

**Future Vulnerability:** When the past rates of change are projected forward on the undefended sections of coast, there are three areas of major change. The central and southern section of the 2050 future shoreline show substantial retreat through the main dune ridge and into the interior of the National Nature Reserve. Whilst this is likely to result in the loss of habitats, given the anticipated dominance of natural processes this is unlikely to be interpreted as damage, rather natural change. Closer to the kart track and the golf club, the influence of defences is likely to be greater. The erosion initiates at the end of the defences, and may open a flood channel (if the dune ridge is breached). Two buildings at the kart track lie some 60m from the 2050 MHWS line (Figure 3.31), however these buildings are likely to be flooded before they are eroded (as was the case in 2014).

The future coast 2050 also shows an erosional bight along the golf course frontage. Whilst the shore is defended and has been since the early 1970s; there is a low-lying section of coast whose defences approaching the fifth green, have deteriorated through time (confirmed by time-series air photos). During two east-coast storms in 2014, substantial damage occurred along the whole of the links, and sections of the boulder defence at the golf course failed and erosion propagated inland. For this reason and the continued weak point here, the shoreline has been projected landward at the past rate (this is not normally done for defended shores).

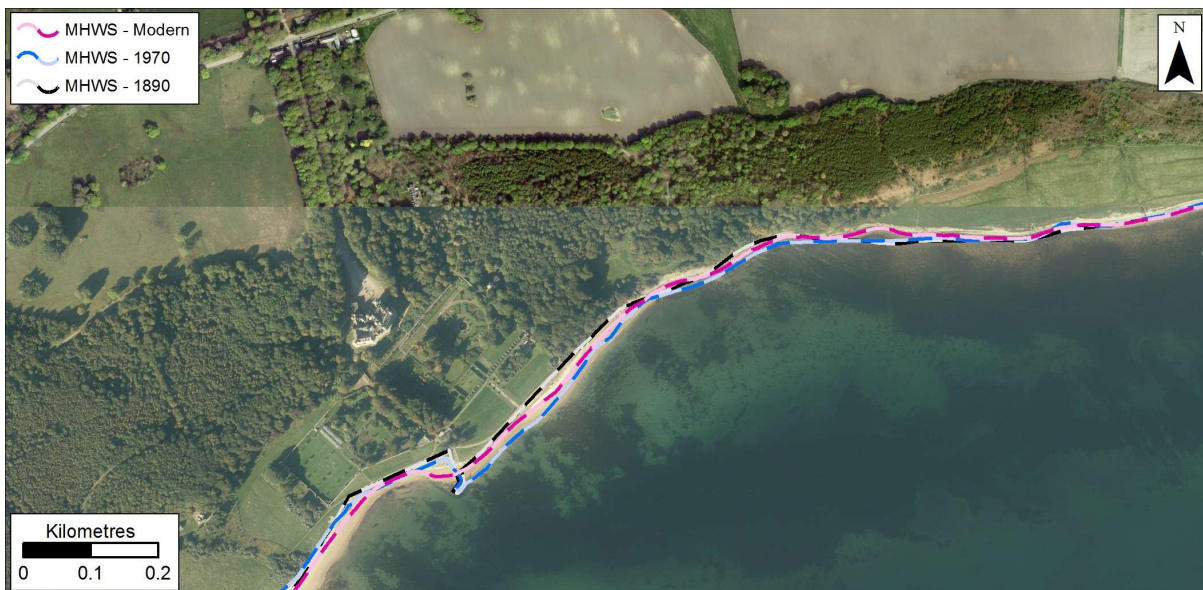
Figure 3.32: MHWS position in 1890, 1970s, and Modern datasets at Dunrobin Castle. Getmapping are our current providers of Scotland-wide digital aerial imagery© Getmapping plc.

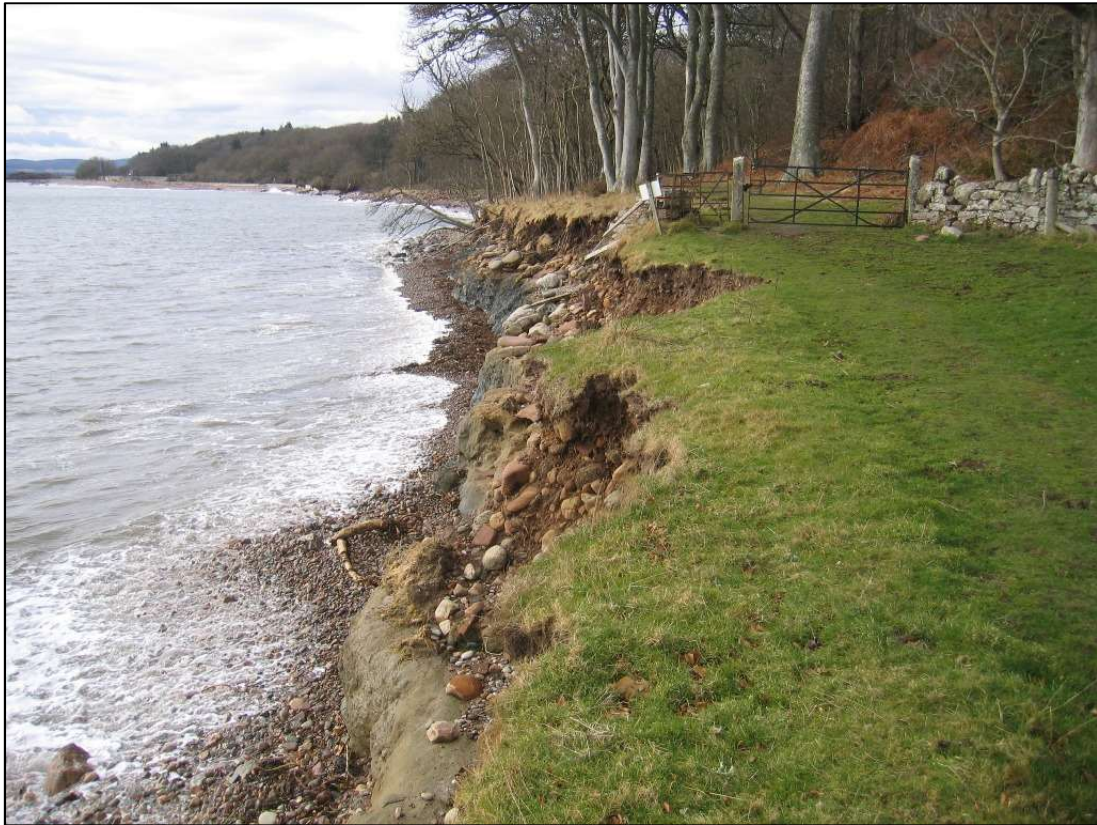
Figure 3.33: Evidence of erosion at Dunrobin Castle in 2000.

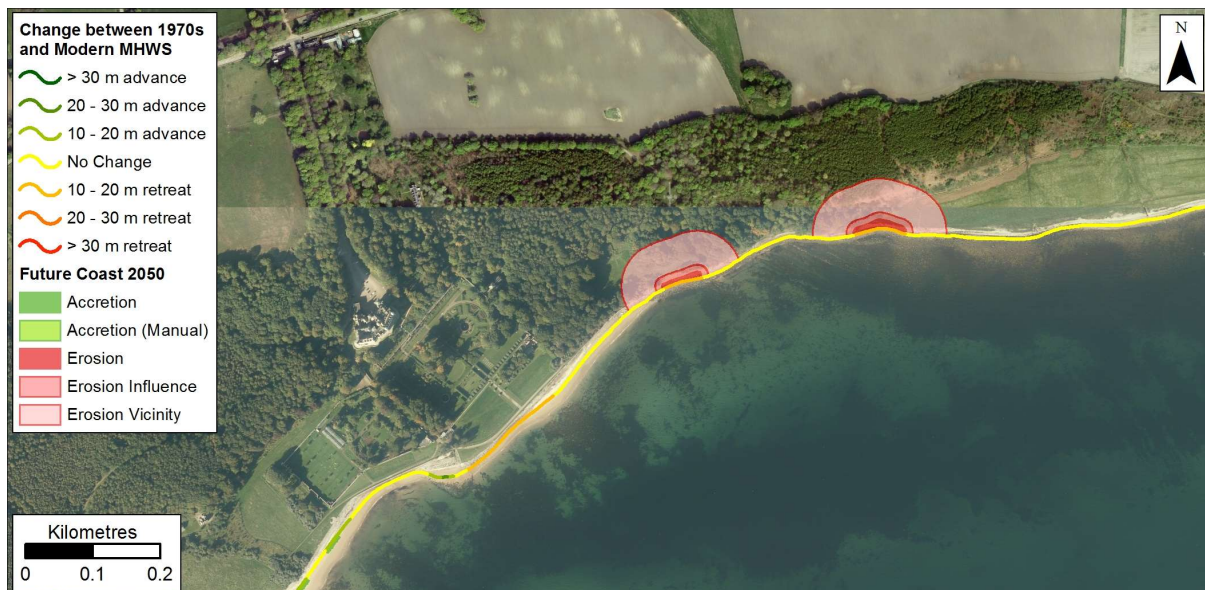
Figure 3.34: MHWS position in 1890 and 1970s, and the change between 1970s and Modern MHWS position at Dunrobin Castle. Getmapping are our current providers of Scotland-wide digital aerial imagery © Getmapping plc.

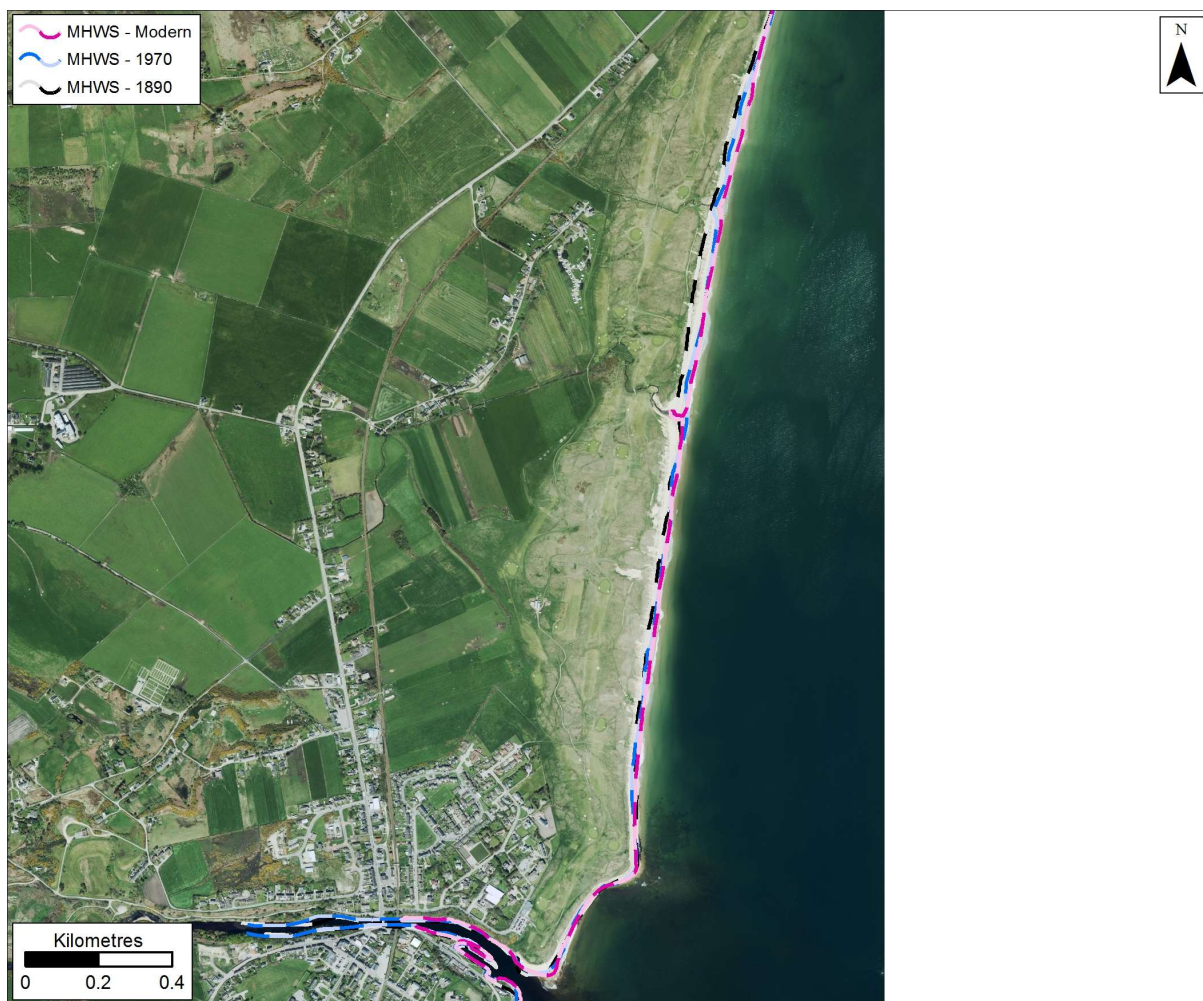
Figure 3.35: MHWS position in 1890, 1970s, and Modern datasets at Brora. Getmapping are our current providers of Scotland-wide digital aerial imagery© Getmapping plc.

To the north of the river's mouth, the 2013 shoreline has fluctuated within 10 m of the 1904 position, however in 1964 MHWS was located further landward than the 2013 position. Unfortunately, the Brora shore experienced storm damage (as did adjacent shores) in two storms in 2014, which post-dates the 2013 LiDAR survey. A 2015 air survey was commissioned by SNH which at the time of writing has not yet been processed into a quality assurance approved surface.

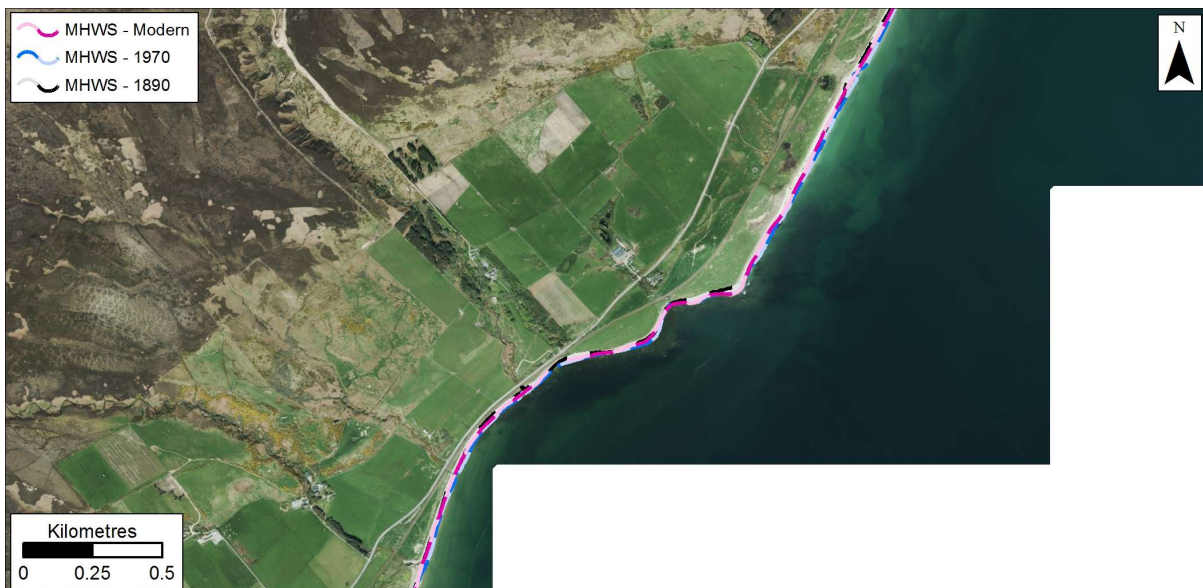
Figure 3.36: MHWS position in 1890, 1970s, and Modern datasets between Brora and Lothbeg Point. Getmapping are our current providers of Scotland-wide digital aerial imagery© Getmapping plc.

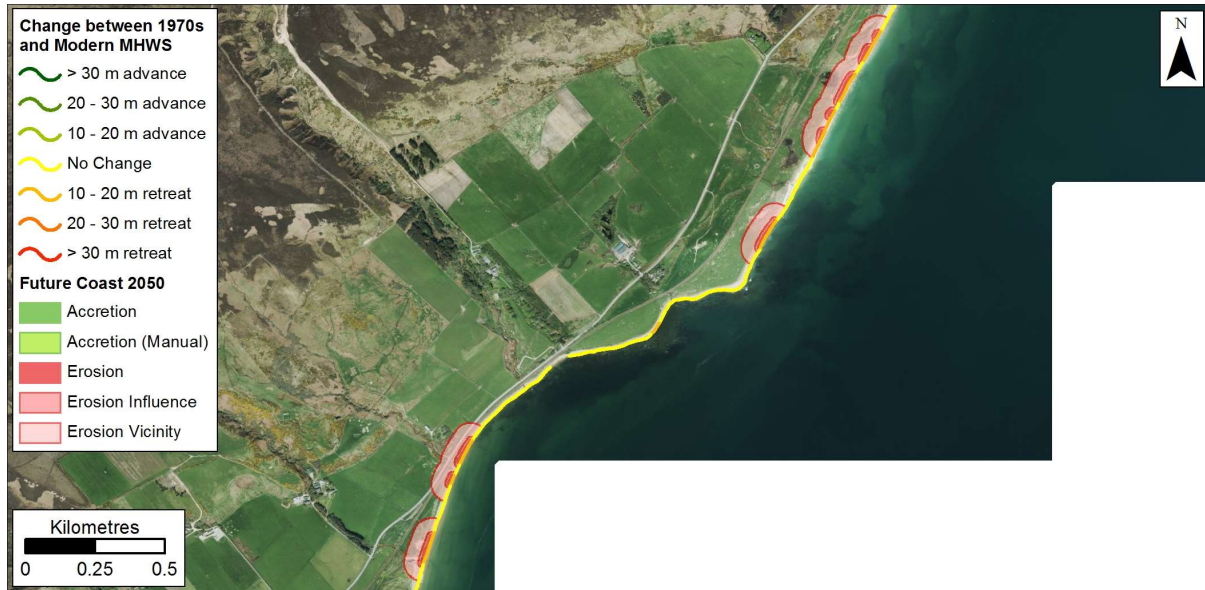
Figure 3.37: Possible future coastline position in 2050 based on rates between 1970 and Modern MHWS data between Brora and Lothbeg Point. Getmapping are our current providers of Scotland-wide digital aerial imagery© Getmapping plc.

**Future Vulnerability:** Whilst there are numerous sections of coastline where the railway line runs along MHWS or adjacent to it, it is to the north of Dunchalm where the past rates suggest the railway may be affected by erosion by 2050 (Figure 3.37). Whilst the 2050 MHWS lies within 10m of the line, this is likely to be close enough for wave carried sediments and water to hinder its use. In addition, the proximity of the A9 to the anticipated future MHWS along this stretch of coast gives cause for concern.
