Dynamic Coast - National Coastal Change Assessment: Cell 1 - St Abb's Head to Fife Ness

Dynamic Coast – Scotland's National Coastal Change Assessment

Executive Summary

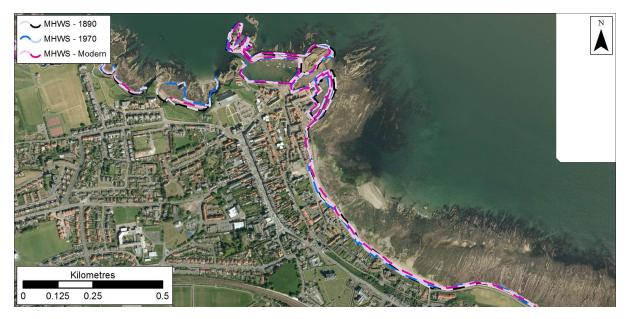
Figure 1.3: MHWS position in 1890, 1970s, and Modern datasets at Dunbar. Getmapping are our current providers of Scotland-wide digital aerial imagery[©] Getmapping plc.

Historical Change: Whilst much of the shoreline has remained stable, to the east of Dunbar, at the site where the Torness Power station is now located, there has been 300 m of land claim over 800 m of coast. This section of coast is now stable and protected by an artificial boulder embankment so that no change is detectable between 1970 and modern. Dunbar east beach, to the southeast of Dunbar harbour, is backed by an assortment of old masonry seawalls and has seen significant seaward movement in MHWS between 1983 and 2011 (Figure 1.3). More recently however, the beach levels were anecdotally reported by the Dunbar Beach Action Group as having dropped following storm events in winter 2013/2014. A proposal (2016) is in place to feed the beach with sediment to restore its recreational and protective potential. Immediately to the west of the harbour, the first embayment has experienced between 16 m (east end) and 48 m (west end) coastal retreat between 1983 and 2011. The rocky intertidal foreshore and high bluffs to the rear will likely limit future retreat rates. This is also the case for the coastline to the west that fronts the golf course as far as the entrance to Belhaven Bay.

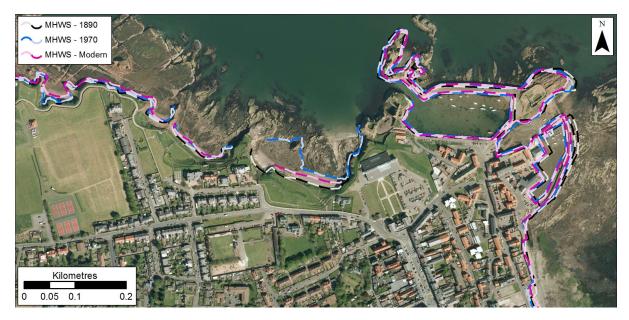
Figure 1.4: MHWS position in the 1970s, and Modern datasets at Dunbar Harbour. Getmapping are our current providers of Scotland-wide digital aerial imagery© Getmapping plc.

Future Vulnerability: The area west of Dunbar Harbour is anticipated to experience erosion by 2050 (Figure 1.4 and Figure 1.5). The assets affected are environmental (nature conservation sites in the Firth of Forth) in the first instance. Further landward and within the erosion vicinity polygon, a 90 m (0.09 km) section of road and at least three properties lie within the potentially erodible area. This location also includes a Potentially Vulnerable Areas (PVA), the Battle of Dunbar Battlefield, the Firth of Forth Special Protected Areas (SPA) and Site of Special Scientific Interest.

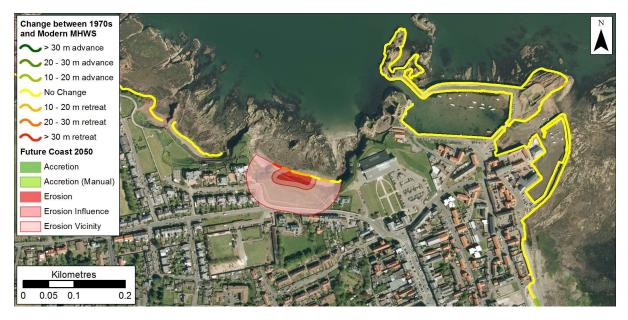
Figure 1.5: Possible future coastline position in 2050 based on rates between 1970 and Modern MHWS data. Getmapping are our current providers of Scotland-wide digital aerial imagery[©] Getmapping plc.

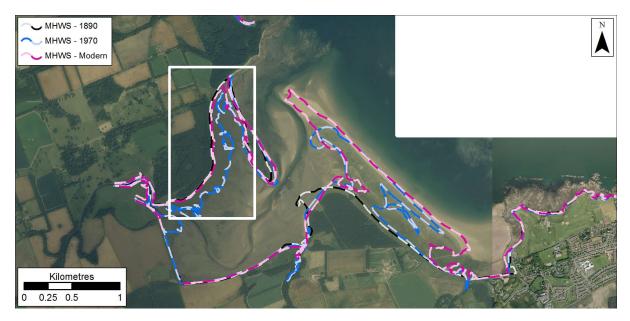
Figure 1.6: MHWS position in 1890, 1970s, and Modern datasets at John Muir Country Park. The white box delineates the area of saltmarsh referred to in the text. Getmapping are our current providers of Scotland-wide digital aerial imagery[©] Getmapping plc.

Historic Change: The Belhaven Bay shoreline at John Muir Country Park has seen considerable changes since the 1890s (Figure 1.6). The central section of beach, dunes and backing salt marshes have built up and extended seawards by over 350 m between 1893 and 1970 and extended

northwest by 580 m. Since 1970, the beach and dunes have continued to extend but rather than seawards they have extended alongshore towards the north east by 450 m and to the south west by 250 m. Some erosion has occurred within the River Tyne exit, most likely due to the movement of the main river channel, which in turn is in response to a modest extension of the inner spit of Sandy Hurst. The position of Sandy Hurst has not changed substantially since 1893. However, the 2011 position of MHWS on the salt marshes on the northern shore (area within the white box in Figure 1.6) appears to coincide with the position plotted in 1893. In the 1970s, it is depicted as being located some 160 m to the southeast (seaward) of the 1893 and 2011 position. Such a major retreat of MHWS across the salt marsh contrasts with the apparent extent of marsh shown on aerial imagery and it is likely that the method of survey of the saltmarsh edge differs from that used in 1893 and that used now. As a result, the 1970 position is subject to some doubt and this point is discussed in the National Overview Report. This location also includes the Firth of Forth SPA and SSSI.

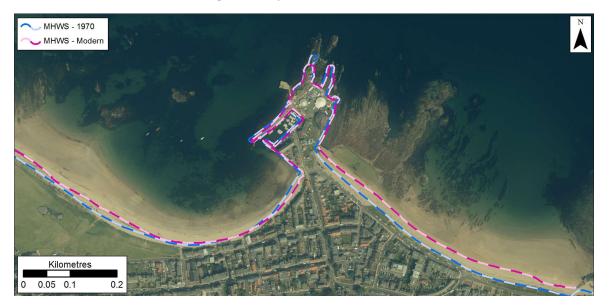
Figure 1.8: MHWS position in the 1970s, and Modern datasets at North Berwick. Getmapping are our current providers of Scotland-wide digital aerial imagery[©] Getmapping plc.

Historic Change: To the east of the harbour along the seafront of North Berwick, the position of MHWS has either remained stable or shown minor advance between 1893 and 1992 although the 8 m of advance is below the threshold (10 m) of significant change. Between 1992 and 2011 there has been seaward advance of some 18 m (i.e. 0.9 m/yr) along much of the eastern beachfront. To the west of the harbour, between 1890 and 1970 the shoreline remained largely stable although immediately to the south of the harbour the beach advanced some 9m (0.1 m/yr). This trend was reversed between 1991 and 2011 with 12 m (0.5 m/yr) of erosion occurring immediately south of the harbour wall and 15m of accretion at the western end of the beach (0.6 m/yr) (Figure 1.8). The foreshore at North Berwick is designated as part of the Firth of Forth SPA and SSSI.

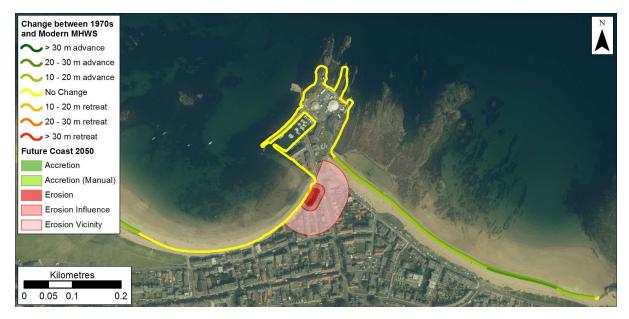
Figure 1.9: Possible future coastline position in 2050 based on rates between 1970 and Modern MHWS data at North Berwick. Getmapping are our current providers of Scotland-wide digital aerial imagery© Getmapping plc.

Future Vulnerability: The Vulnerability Assessment used the current erosion and accretion rates and projects them forward to 2050. Since much of the beachfront either side of the harbour shows accretion then these are predicted to continue to 2050 and are depicted via the green accretion area bars on Figure 1.9. However, in the area immediately adjacent and south of the harbour the predicted erosion by 2050 area impinges on one building with the erosion influenced area capturing a further four buildings and residences. The area of erosion vicinity includes a further 34 buildings and residences as well as significant length of Victoria Road and Melbourne Road, the only access routes to the harbour.

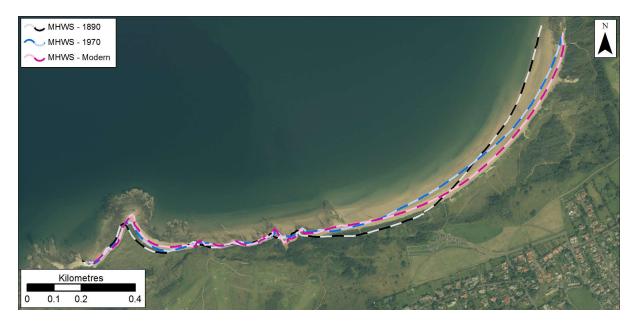
Figure 1.10: MHWS position in 1890, 1970s, and Modern datasets at Gullane Bay. Getmapping are our current providers of Scotland-wide digital aerial imagery© Getmapping plc.

Historic Change: Much of the shoreline east of Gullane is characterised by cliffs with pocket or clifffoot beaches that have remained stable or have shown minor accretion between 1890, 1970 and modern (Figure 1.10). A minor amount of erosion has occurred between 1970 and modern at the western edge of a north-east facing beach to the north of Muirfield Golf Course and west of Dirleton. At Gullane, the beach has undergone a substantial amount of reshaping between 1890 and modern with erosion of 40 m (1890-1970) and up to 35 m (1970-modern) at the northern and central sections, and accretion of 25 m (1890-1970) and 15 m (1970-modern) in the western end. The accretion trend continues toward the headland to the west but at much reduced amounts.

Further west, substantial accretion dominates within Aberlady Bay, particularly on the eastern side where 100 m accreted between 1980 -1970 (ca 1 m/yr) and a further 330 m 1990-2011 (ca 15 m/yr). The south side of the bay has seen only minor accretion or stability over the same time spans as above. Aberlady Bay is part of the Firth of Forth SPA.

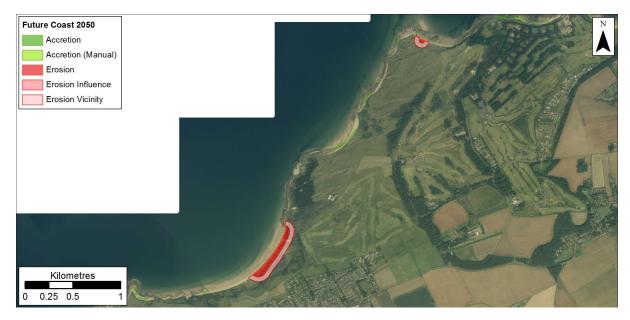
Figure 1.11: Possible future coastline position in 2050 based on rates between 1970 and Modern MHWS data at Gullane Bay. Getmapping are our current providers of Scotland-wide digital aerial imagery© Getmapping plc.

Future Vulnerability: The Vulnerability Assessment used the current erosion and accretion rates and projects them forward to 2050. Because of past erosional trends in the northern part of Gullane beach, the future look of vulnerability depicts a significant length of shoreline (600 m) to be potentially erosion-affected by 2050, with the erosion zone extending 50 m inland and the erosion influenced zone at 60 m inland (Figure 1.11). There are no built assets within this zone with the nearest residential properties a further 200 m inland and situated on top of a cliffline.

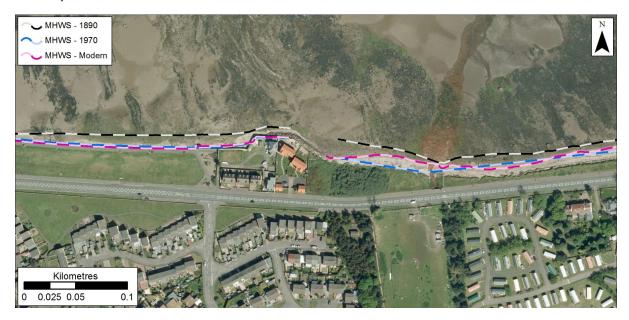
Figure 1.12: MHWS position in 1890, 1970s, and Modern datasets at Port Seton. Getmapping are our current providers of Scotland-wide digital aerial imagery© Getmapping plc.

Future Vulnerability: Much of the foreshore at Port Seton has a veneer of sediments partially covering a rocky foreshore. The shoreline has retreated between 1890 and 1970, however to the eastern half of Figure 1.12, recent advances can be seen of up to 17 m and up to 12 m towards the west. There is little recent change adjacent and to the west of the coast protection in front of a small collection of buildings in the middle of the map. Such a location would not normally merit inclusion; however aerial photography clearly shows the undermining of a grassed area landward of the seawall. So, whilst no damage is known to have occurred to property, this demonstrates the fallibility of seawalls in some situations.

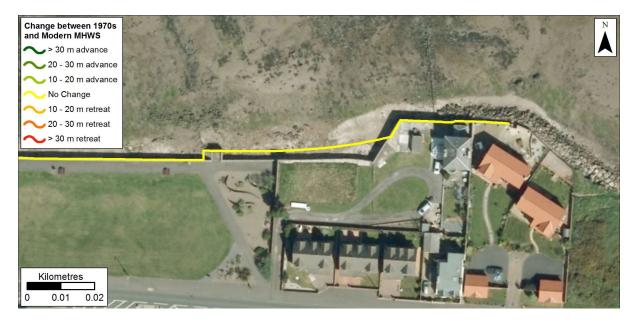
Figure 1.13: Aerial photography from 2009-05-11 showing the initial situation, with the grassed area behind seawall unaffected, see Figure 1.14 for comparison. Getmapping are our current providers of Scotland-wide digital aerial imagery[©] Getmapping plc.

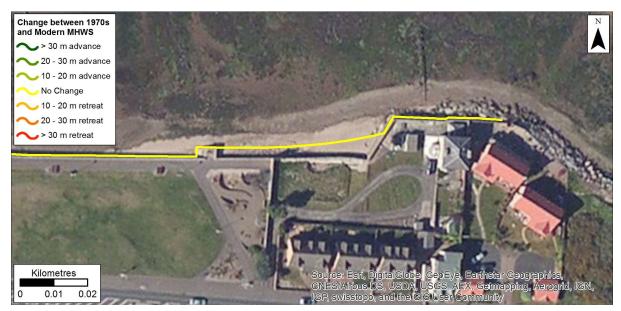
Figure 1.14: Esri default air photography taken on 2011-05-01 showing an area of undermining landward of the sea wall, see Figure 1.13 for comparison.

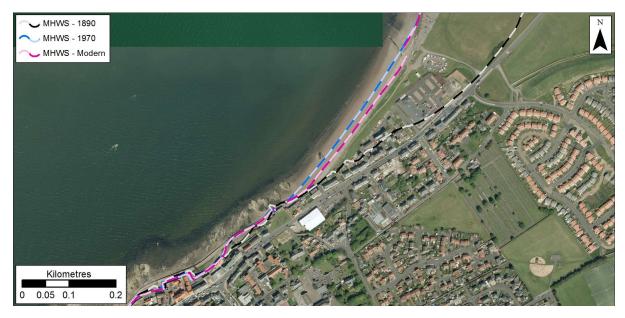
Figure 1.15: MHWS position in 1890, 1970s, and Modern datasets at Prestonpans. Getmapping are our current providers of Scotland-wide digital aerial imagery[©] Getmapping plc.

Historic Change: Much of the shoreline between Cockenzie and Prestonpans has either accreted or been subject to land claim after 1890 to house Cockenzie Power Station (Figure 1.15) and so the shoreline has since been protected with hard defences over much of its length. The one exception to this is along the urban frontage of Prestonpans itself where a 450m section of the beach is unprotected and has undergone erosion of ca 14m along its length between 1970 and modern. The western part of the town is protected by various generations of sea wall but beyond that the shore is unprotected north of Musselburgh Golf Course (Figure 1.16). It is possible that the coastline here once had coastal defences but these have now failed and bypassed. The shoreline is substantially seawards of the 1890 position suggesting land claim. However, there has been landward movement

of MHWS between 1970 and modern of 15-25 m along the northern shore and accretion of up to 50m on the west facing shore. Prestonpans is a Potentially Vulnerable Area, is home to the Battle of Pinkie Battlefield and the Firth of Forth Special Protection Area along its foreshore.

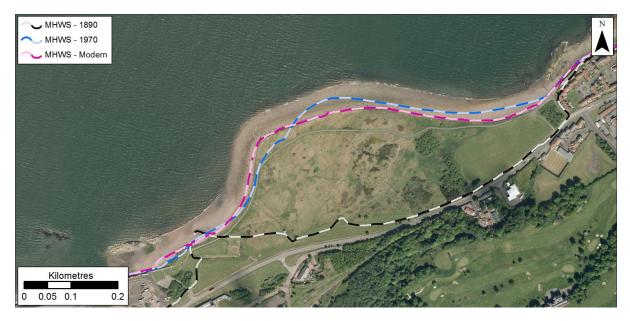
Figure 1.16: MHWS position in 1890, 1970s, and Modern datasets at east of Prestonpans. Getmapping are our current providers of Scotland-wide digital aerial imagery© Getmapping plc.

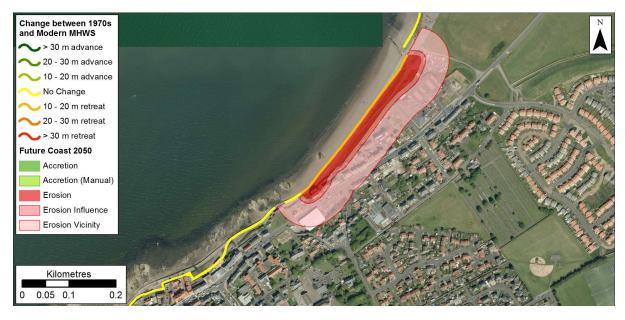
Figure 1.17: Possible future coastline position in 2050 based on rates between 1970 and Modern MHWS data in Prestonpans. Getmapping are our current providers of Scotland-wide digital aerial imagery[©] Getmapping plc.

Future Vulnerability: The Vulnerability Assessment used the current erosion and accretion rates and projects them forward to 2050. At the present rate of erosion of the unprotected shoreline at Musselburgh, the future area of vulnerability (Figure 1.17) spans 380 m of linear coast and extends 23 m inland affecting three commercial properties and one residential property. The erosion influenced area captures another four properties whilst the vicinity influences a further 21 properties, the High Street and an electricity substation. To the west of Musselburgh, future

erosional vulnerability affects 500 m of linear shore and extends 25 m inland. This erosion affected area is mainly undeveloped land, though the erosion vicinity does impinge on a short stretch of the western extension of the High Street.

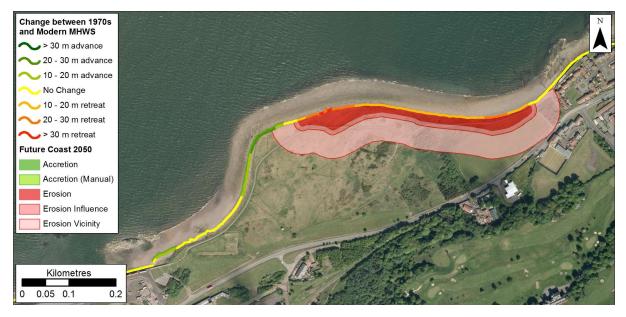
Figure 1.18: Possible future coastline position in 2050 based on rates between 1970 and Modern MHWS data east of Prestonpans. Getmapping are our current providers of Scotland-wide digital aerial imagery© Getmapping plc.

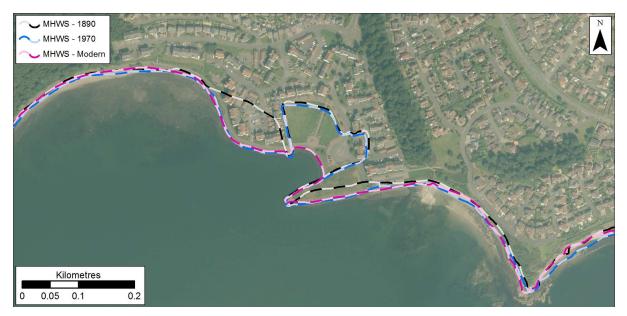
Figure 1.19: MHWS position in 1890, 1970s, and Modern datasets at Dalgety Bay. Getmapping are our current providers of Scotland-wide digital aerial imagery[©] Getmapping plc.

Historic Change: The coastline at Dalgety Bay is now mostly protected or is rocky along its length and shows only minor fluctuations in the positions of MHWS over time (1890-modern). The one exception occurs at Harbour Place where the 1890 and 1970 shore positions show an inlet that once may have been a small harbour. The modern shore shows this inlet to have been removed, probably the subject of land claim post 1970 and the shoreline is now artificially protected. The foreshore at Dalgety Bay is part of the Firth of Forth Special Protection Area.

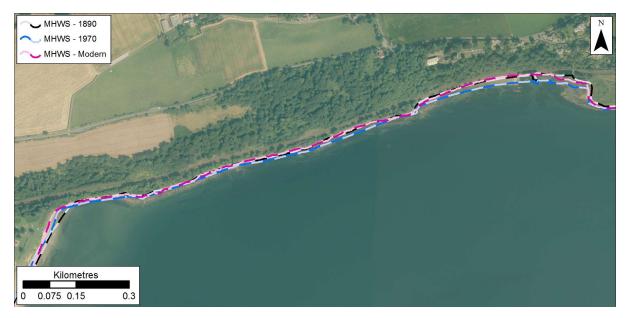
Figure 1.20: MHWS position in 1890, 1970s, and Modern datasets at Aberdour and Burntisland. Getmapping are our current providers of Scotland-wide digital aerial imagery[©] Getmapping plc.

Historic Change: The coastline between Aberdour and Burntisland is backed by a rock cliff that falls to a low platform along which the rail line to Kirkcaldy runs. Between 1970 and modern, the shoreline has receded by 10-20 m with most erosion occurring in the east. Similar amounts of erosion have occurred in the past in the west but this section is now protected by a boulder revetment.

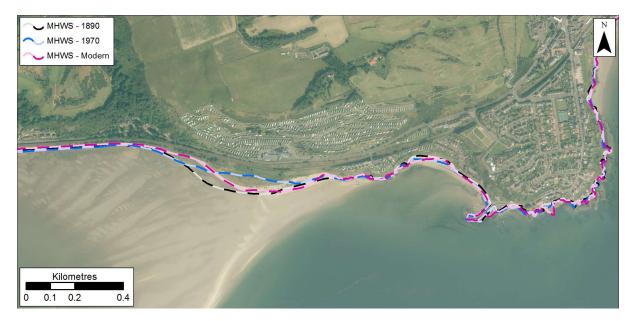
Figure 1.21: MHWS position in 1890, 1970s, and Modern datasets at Kinghorn. Getmapping are our current providers of Scotland-wide digital aerial imagery[©] Getmapping plc.

Historic Change: To the west of Kinghorn the coast has shown minor erosion of up to 10m between 1970 and modern along the length of coast where the rail line runs, although the 1890 MHWS now coincides with the modern line. East of this there has been significant accretion beyond the end of the boulder revetment that protects the rail line. However, at the end of the revetment some 24m of erosion has occurred (1970-modern) that will continue unless the revetment is extended. East of this at Kinghorn itself, between 1970 and modern there has been 12 m of erosion over 120 m of the eastern end of Pettycur Bay. Accretion has characterised the western end of the bay. The foreshore at Kinghorn is notified as a part of the Firth of Forth Special Protection Area and a Site of Special Scientific Interest.

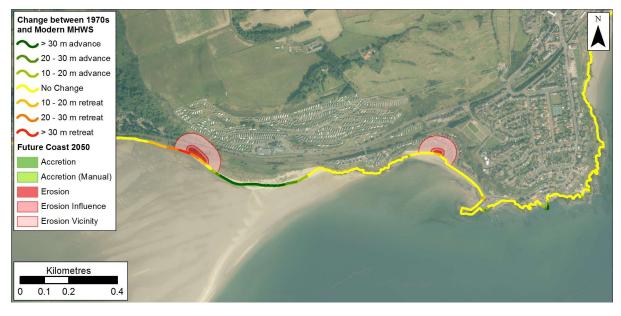
Figure 1.22: Possible future coastline position in 2050 based on rates between 1970 and Modern MHWS data at Kinghorn. Getmapping are our current providers of Scotland-wide digital aerial imagery© *Getmapping plc.*

Future Vulnerability: The Vulnerability Assessment used the current erosion and accretion rates and projects them forward to 2050. In the west, the area of erosion impacts mainly beach and dune but the erosion influenced area captures 30 m of rail line with a further 50 m within the erosion vicinity footprint. Moving east to Pettycur Bay, a continuation of the erosion trend produces erosion of the beach and dune area over 30m at the eastern end of the bay and with the erosion vicinity impinging on 16 residential properties and their suburban access road.

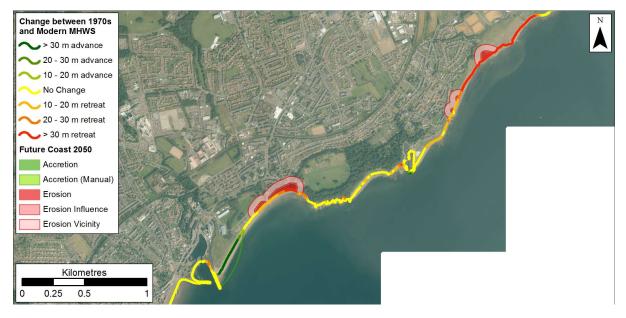
Figure 1.24: Possible future coastline position in 2050 based on rates between 1970 and Modern MHWS data in Dysart. Getmapping are our current providers of Scotland-wide digital aerial imagery© Getmapping plc.

Future Vulnerability: The Vulnerability Assessment used the current erosion and accretion rates and projects them forward to 2050. At Ravenscraig Park the future erosion vulnerability footprint largely affects beach and parkland but within the vicinity of erosion area lie six residential properties, part

of the Kyles Road and a small section of the A955 (Figure 1.24). To the north of this section lie two areas of future vulnerability. The southernmost of which affects a section of Howard Place and The Walk and includes eight residential properties within the erosion vicinity footprint. The northern area lies close to Edington Place affecting 100 m of shore and 50 m inland but no properties at risk. It is likely that this area is made ground composed of coal waste.

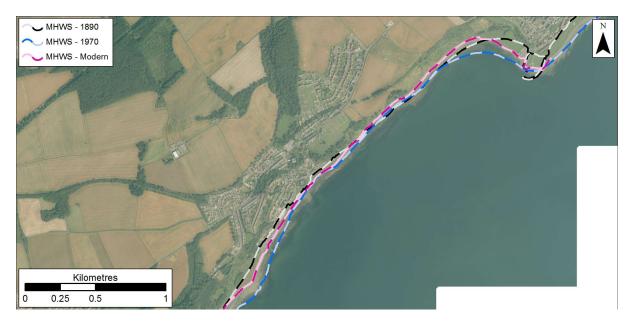
Figure 1.26: MHWS position in 1890, 1970s, and Modern datasets at East Wemyss. Getmapping are our current providers of Scotland-wide digital aerial imagery© Getmapping plc.

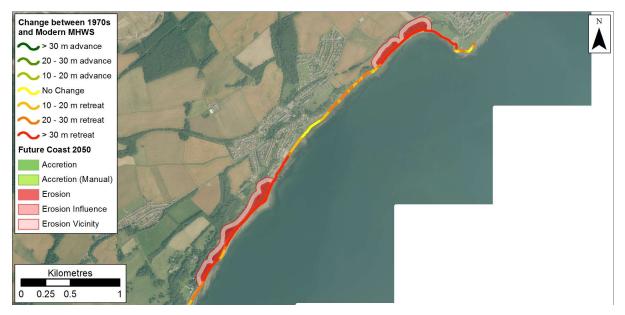
Figure 1.27: Possible future coastline position in 2050 based on rates between 1970 and Modern MHWS data at East Wemyss. Getmapping are our current providers of Scotland-wide digital aerial imagery[©] Getmapping plc.

Future Vulnerability: The Vulnerability Assessment used the current erosion and accretion rates and projects them forward to 2050. Much of the rapidly eroding area that starts at the south end of East Wemyss (at Back Dykes road) affects undeveloped ground characterised by bluffs of easily eroded glacial till (Figure 1.27), although one non-residential property lies within the erosion vicinity area. Since the frontage of East Wemyss itself is now protected by a boulder revetment, there are no extant future vulnerability issues noted. The area to the north and closer to Buckhaven has a 600 m long erosion footprint that affects mainly undeveloped land.

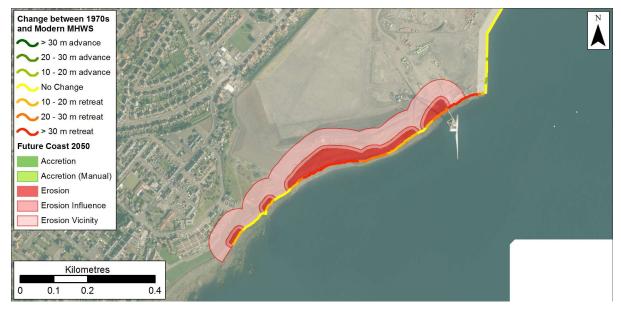
Figure 1.29: Possible future coastline position in 2050 based on rates between 1970 and Modern MHWS at Buckhaven. Getmapping are our current providers of Scotland-wide digital aerial imagery© Getmapping plc.

Future Vulnerability: The Vulnerability Assessment used the current erosion and accretion rates and projects them forward to 2050. Some 650 m of coast is vulnerable but much of this in the north affects made ground (Figure 1.29), likely of colliery waste. In the south however, at Shore Street and Lady Wynd, some 50 m of shore is vulnerable with the footprint of erosion vulnerability extending 100 m inland and affecting 11 residential properties and an electricity substation as well as some 130 m of Shore Street roadway.

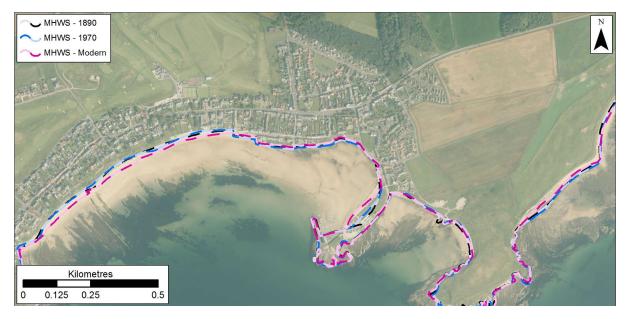
Figure 1.30: MHWS position in 1890, 1970s, and Modern datasets at Earlsferry. Getmapping are our current providers of Scotland-wide digital aerial imagery[©] Getmapping plc.

Historic Change: At Elie the accretion that occurred between 1890 and 1970 was reversed from 1970 to modern and the MHWS line migrated landward to reoccupy its 1890 position. Since then much of the shoreline has been subject to various protection measures that have halted any further

landward excursion, other than a very small area of shore at The Terrace where some 10 m has been lost since 1970. To the east of Elie, the beach and dune frontage has moved landward by up to 20 m over much of the foreshore between 1970 and modern, a trend that has accelerated since the 1890 position (Figure 1.30). East of Sauchar Point the foreshore and dunes are part of the Firth of Forth Site of Special Scientific Interest.

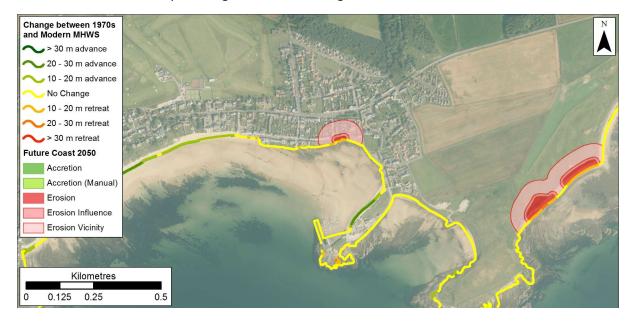
Figure 1.31: Possible future coastline position in 2050 based on rates between 1970 and Modern MHWS data at Earlsferry. Getmapping are our current providers of Scotland-wide digital aerial imagery[©] *Getmapping plc.*

Future Vulnerability: The Vulnerability Assessment used the current erosion and accretion rates and projects them forward to 2050. The erosion of over 400 m of linear coast to the east of Elie affects beach and dune land with no built assets located in the area (Figure 1.31). However, the vulnerability of the urban area within Elie at The Terrace and Stenton Row places 15 properties at risk as well as the roadways leading south from the High Street.
